# OIL ANALYSIS REPORT

**LS-043024-01B-200C**

**Chain**

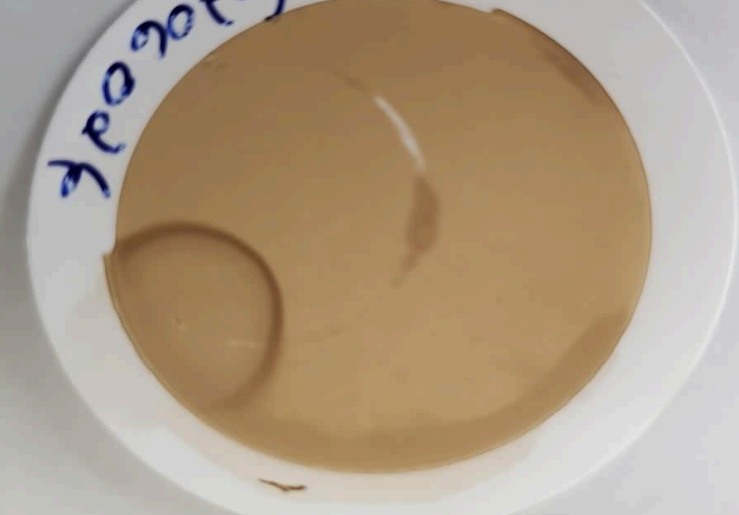
MPC (Varnish Test)

MPC (Membrane Patch Colorimetry) test indicates a moderate concentration of varnish present.

method	limit/base	current	history1	history2
MPC Varnish Potential	Scale	ASTM D7843	>15 <b>▲ 35</b>	---	---

This is a baseline read-out on the submitted sample.
