OIL ANALYSIS REPORT

Sample No. : USPM37771

KraftHeinz - Kirksville - Plant 8333 USP

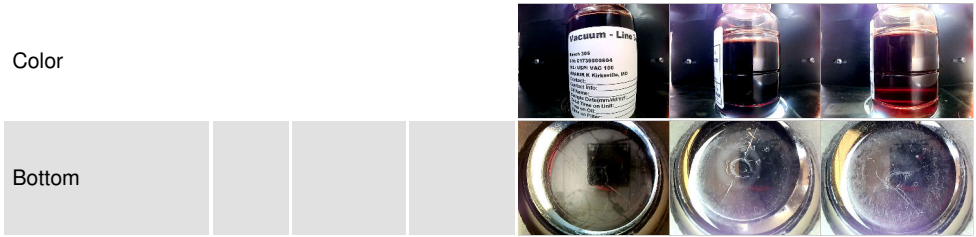
SAMPLE IMAGES	method	limit/base	current	history1	history2
---------------	--------	------------	---------	----------	----------

VISUAL	method	limit/base	current	history1	history2
White Metal	scalar	*Visual	NONE	NONE	NONE
Yellow Metal	scalar	*Visual	NONE	NONE	NONE
Precipitate	scalar	*Visual	NONE	NONE	NONE
Silt	scalar	*Visual	NONE	NONE	NONE
Debris	scalar	*Visual	NONE	NONE	LIGHT
Sand/Dirt	scalar	*Visual	NONE	NONE	NONE
Appearance	scalar	*Visual	NORML	NORML	NORML
Odor	scalar	*Visual	NORML	NORML	NORML
Emulsified Water	scalar	*Visual	>.1	NEG	NEG
Free Water	scalar	*Visual		NEG	NEG

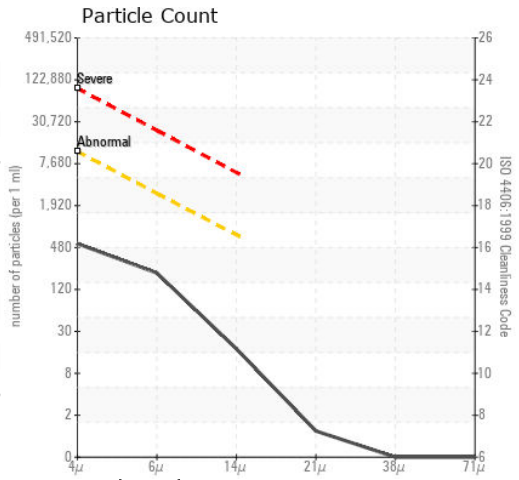
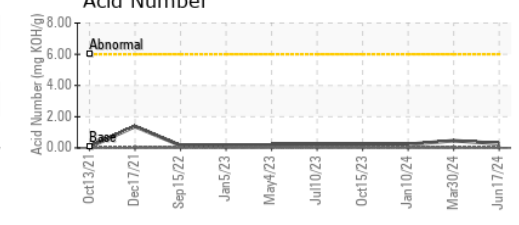
GRAPHS

FLUID PROPERTIES	method	limit/base	current	history1	history2
Visc @ 40°C	cSt	ASTM D445 91	105	104	106
