# OIL ANALYSIS REPORT

**Laboratory** : WearCheck USA - 501 Madison Ave., Cary, NC 27513  
**Sample No.** : NX015083      **Received** : 18 Jun 2024  
**Lab Number** : 06213991      **Tested** : 20 Jun 2024  
**Unique Number** : 11086855      **Diagnosed** : 20 Jun 2024 - Don Baldrige  
**Test Package** : IND 2 ( Additional Tests: KF, PQ )

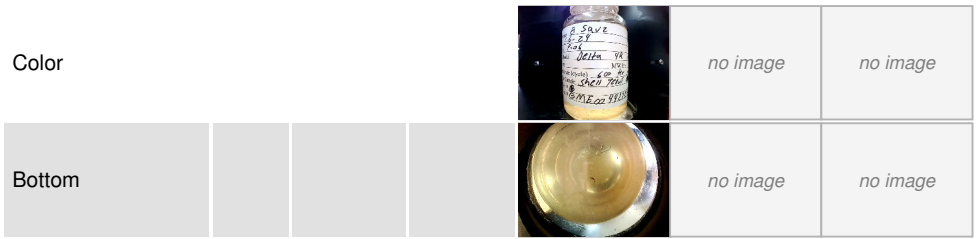
SAMPLE IMAGES	method	limit/base	current	history1	history2
---------------	--------	------------	---------	----------	----------

VISUAL	method	limit/base	current	history1	history2
White Metal	scalar	*Visual	NONE	NONE	---
Yellow Metal	scalar	*Visual	NONE	NONE	---
Precipitate	scalar	*Visual	NONE	NONE	---
Silt	scalar	*Visual	NONE	NONE	---
Debris	scalar	*Visual	NONE	LIGHT	---
Sand/Dirt	scalar	*Visual	NONE	NONE	---
Appearance	scalar	*Visual	NORML	NORML	---
Odor	scalar	*Visual	NORML	NORML	---
Emulsified Water	scalar	*Visual	>0.05	NEG	---
Free Water	scalar	*Visual		NEG	---
