OIL ANALYSIS REPORT

Laboratory : WearCheck USA - 501 Madison Ave., Cary, NC 27513
Sample No. : KCPA012967
Lab Number : 06216907
Unique Number : 11089771
Test Package : IND 2 (Additional Tests: KF, PrtCount)
Received : 21 Jun 2024
Tested : 24 Jun 2024
Diagnosed : 24 Jun 2024 - Doug Bogart

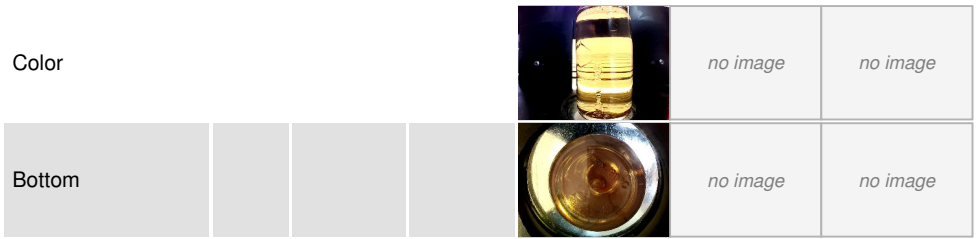
SAMPLE IMAGES	method	limit/base	current	history1	history2
---------------	--------	------------	---------	----------	----------

VISUAL	method	limit/base	current	history1	history2	
White Metal	scalar	*Visual	NONE	NONE	---	---
Yellow Metal	scalar	*Visual	NONE	NONE	---	---
Precipitate	scalar	*Visual	NONE	NONE	---	---
Silt	scalar	*Visual	NONE	NONE	---	---
Debris	scalar	*Visual	NONE	NONE	---	---
Sand/Dirt	scalar	*Visual	NONE	NONE	---	---
Appearance	scalar	*Visual	NORML	NORML	---	---
Odor	scalar	*Visual	NORML	NORML	---	---
Emulsified Water	scalar	*Visual	>0.05	NEG	---	---
Free Water	scalar	*Visual		NEG	---	---
