# PROBLEM SUMMARY

## PALFINGER T87

### Hydraulic System

### AW HYDRAULIC OIL ISO 32 (--- GAL)

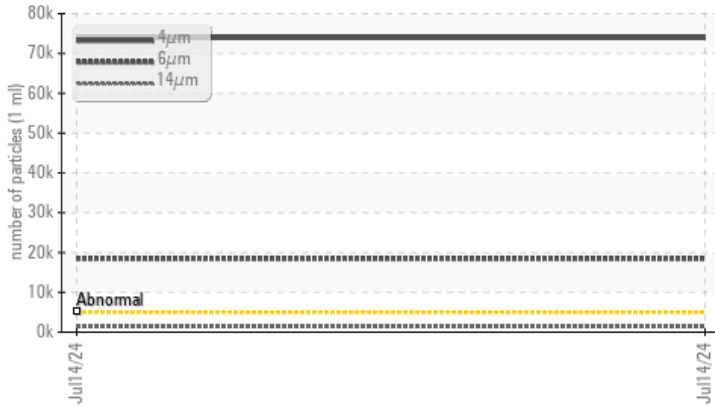
### ▲ Particle Trend

Sample Status			SEVERE	---	---
Particles >4µm	ASTM D7647	>5000	▲ 73930	---	---
Particles >6µm	ASTM D7647	>1300	▲ 18459	---	---
Particles >14µm	ASTM D7647	>160	▲ 1337	---	---
Particles >21µm	ASTM D7647	>40	▲ 334	---	---
Oil Cleanliness	ISO 4406 (c)	>19/17/14	▲ 23/21/18	---	---

There is a high amount of particulates (2 to 100 microns in size) present in the oil.

We advise that you check all areas where contaminants can enter the system. We advise that you perform a filter service, and use off-line filtration to improve the cleanliness of the system fluid. The air breather requires service. If unrated, we recommend that you replace with a suitable micron rated and/or desiccant air breather. If rated, we recommend that you service/replace the breather. Resample in 30-45 days to monitor this situation. The fluid was not specified, however, a fluid match indicates that this fluid is (GENERIC) AW HYDRAULIC OIL ISO 32. Please confirm.

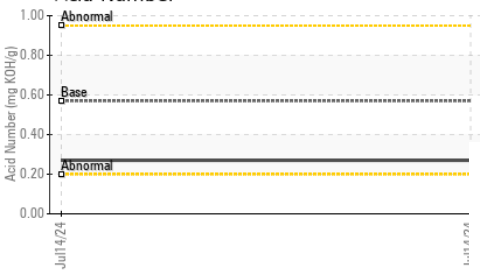
### Acid Number

The AN level is acceptable for this fluid. The oil is still serviceable provided that the contaminant(s) can be reduced to acceptable levels.

FLUID DEGRADATION		method	limit/base	current	history1	history2
Acid Number (AN)	mg KOH/g	ASTM D8045	0.57	<b>0.27</b>	---	---

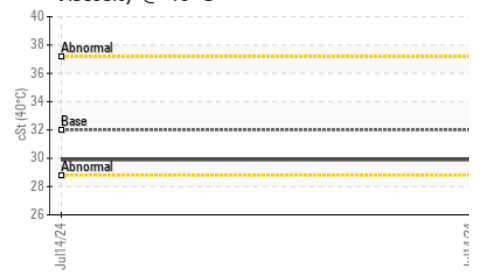
### Viscosity @ 40°C

FLUID PROPERTIES	method	limit/base	current	history1	history2
Visc @ 40°C	cSt	ASTM D445 32	29.9	---	---
