# OIL ANALYSIS REPORT

**Laboratory** : WearCheck USA - 501 Madison Ave., Cary, NC 27513  
**Sample No.** : WC0960432      **Received** : 15 Jul 2024  
**Lab Number** : **06237001**      **Tested** : 18 Jul 2024  
**Unique Number** : 11125835      **Diagnosed** : 18 Jul 2024 - Jonathan Hester  
**Test Package** : MOB 2

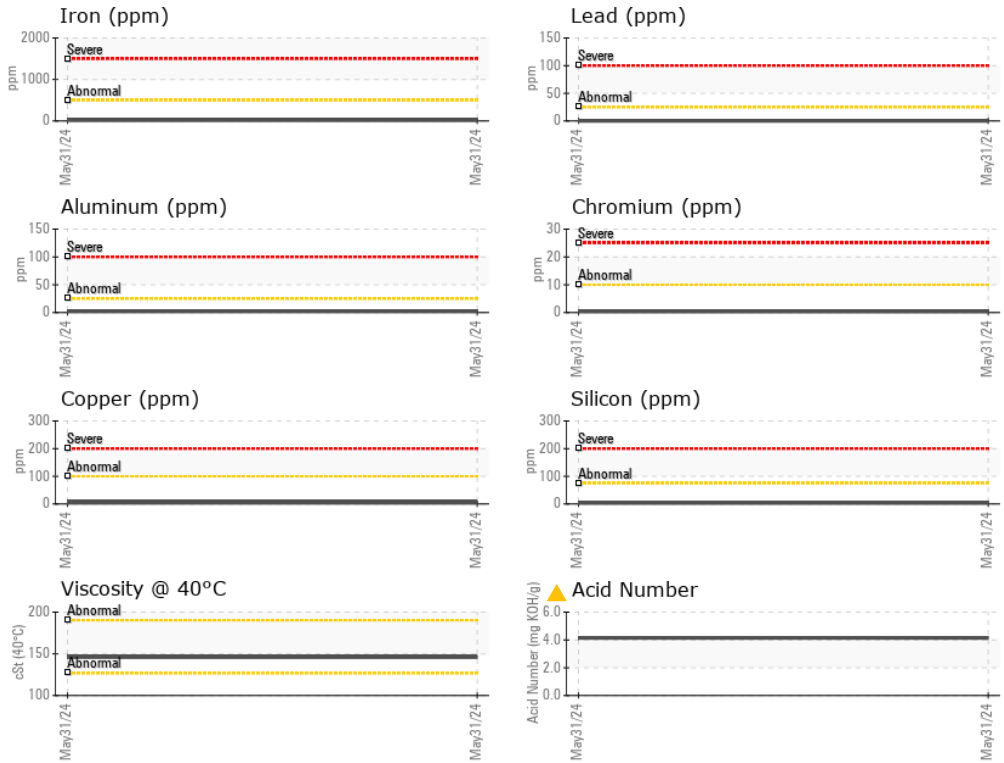
## GRAPHS

VISUAL	method	limit/base	current	history1	history2
White Metal	scalar	*Visual	NONE	<b>NONE</b>	---
Yellow Metal	scalar	*Visual	NONE	<b>▲ MODER</b>	---
Precipitate	scalar	*Visual	NONE	<b>NONE</b>	---
Silt	scalar	*Visual	NONE	<b>NONE</b>	---
Debris	scalar	*Visual	NONE	<b>NONE</b>	---
Sand/Dirt	scalar	*Visual	NONE	<b>NONE</b>	---
Appearance	scalar	*Visual	NORML	<b>NORML</b>	---
Odor	scalar	*Visual	NORML	<b>NORML</b>	---
Emulsified Water	scalar	*Visual	>.2	<b>NEG</b>	---
Free Water	scalar	*Visual		<b>NEG</b>	---

FLUID PROPERTIES	method	limit/base	current	history1	history2
Visc @ 40°C	cSt	ASTM D445	<b>146</b>	---	---
