Laboratoire : WearCheck - C8-1175 Appleby Line, Burlington, ON L7L 5H9
N° d'échantillon : WC
N° de laboratoire : 02640801
Numéro unique : 5789963
Analyse : MOB 1 (Additional Tests: KV100, KV40, Spat, VI)
Reçu : 10 Jun 2024
Tested : 10 Jun 2024
Diagnostiqué : 11 Jun 2024 - Bill Quesnel

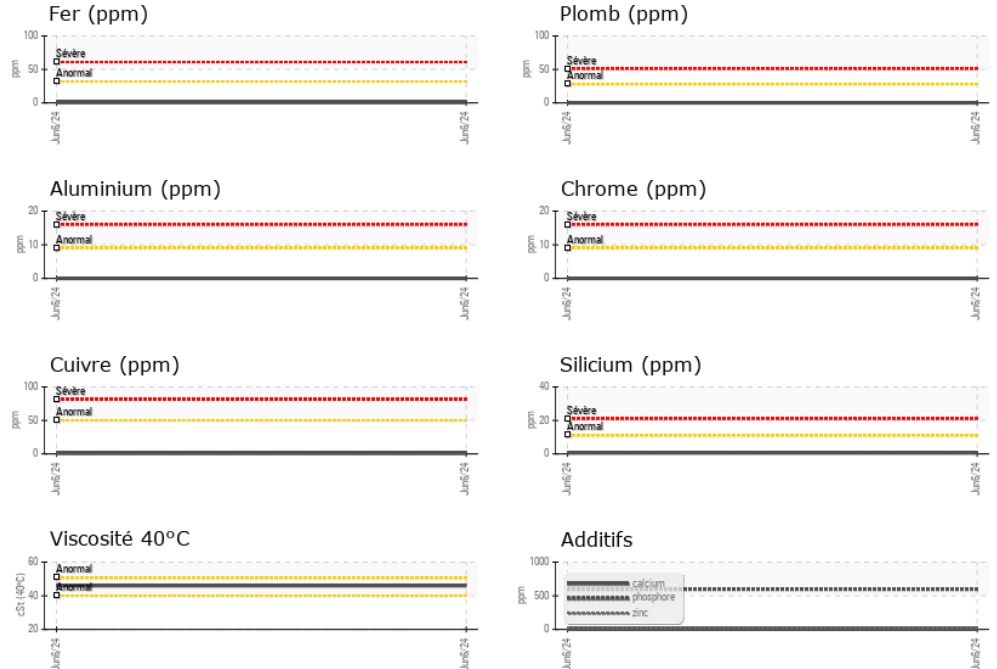
GRAPHIQUES

PROPRIÉTÉS DU FLUID	methode	limite/base	actuel	passé1	passé2
Visc 40°C	cSt	ASTM D7279(m)	46.0	---	---
Visc 100°C	cSt	ASTM D7279(m)	7.4	---	---
Indice de viscosité (VI)	Scale	ASTM D2270*	124	---	---
