**N° de laboratoire** : **02642365**

**Analyse** : MOB 1 ( Additional Tests: KV100, KV40, Spat, VI )

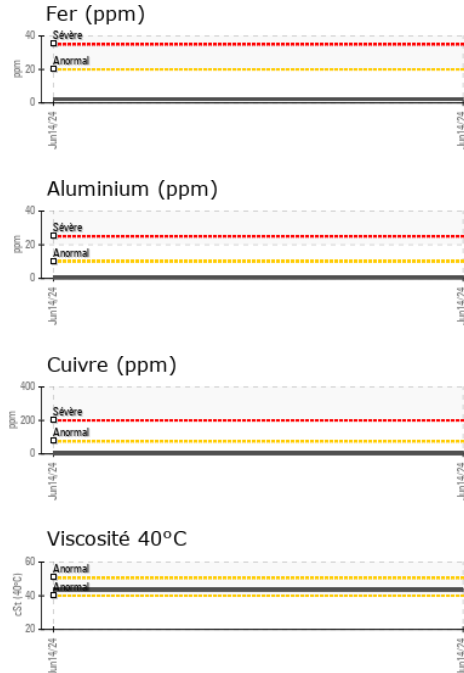
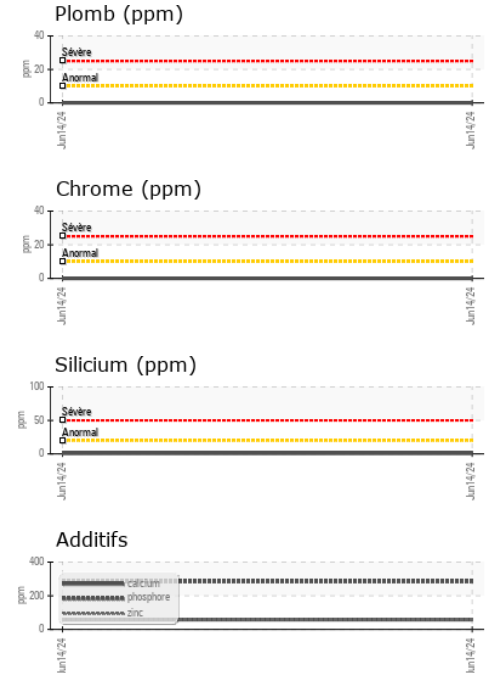
## GRAPHIQUES

PROPRIÉTÉS DU FLUID	methode	limite/base	actuel	passé1	passé2
Visc 40°C	cSt	ASTM D7279(m)	<b>43.4</b>	---	---
Visc 100°C	cSt	ASTM D7279(m)	<b>7.6</b>	---	---
Indice de viscosité (VI)	Scale	ASTM D2270*	<b>143</b>	---	---
