Laboratoire : WearCheck - C8-1175 Appleby Line, Burlington, ON L7L 5H9
N° d'échantillon : WC **Reçu** : 04 Jul 2024
N° de laboratoire : **02645514** **Tested** : 04 Jul 2024
Numéro unique : 5803053 **Diagnostiqué** : 08 Jul 2024 - Bill Quesnel
Analyse : MOB 1 (Additional Tests: KV100, KV40, Spat, VI)

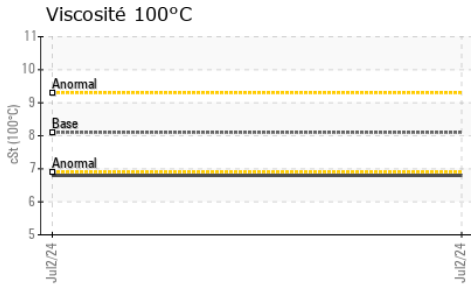
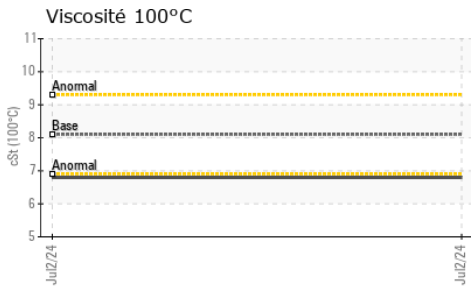
GRAPHIQUES

PROPRIÉTÉS DU FLUID	methode	limite/base	actuel	passé1	passé2
Visc 40°C	cSt	ASTM D279(m)	47.0	46.3	---
Visc 100°C	cSt	ASTM D279(m)	8.1	6.8	---
Indice de viscosité (VI)	Scale	ASTM D2270*	146	100	---
