# CONSTRUCTION EQUIPMENT

## SW35271 VOLVO EC750E 314074 - FRONT LEFT FINAL DRIVE

**Sample No:** VCP436948  
**Oil Type:** VOLVO PREMIUM GEAR OIL 85W-140 GL-5  
**Job No:** SW35271

## SW35271 VOLVO EC750E 314074 - FRONT RIGHT FINAL DRIVE

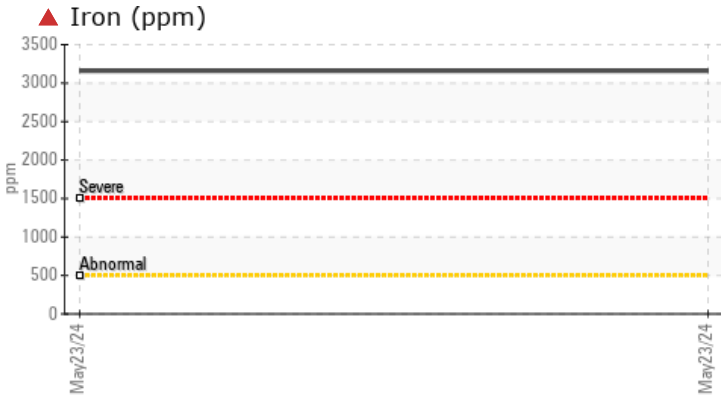
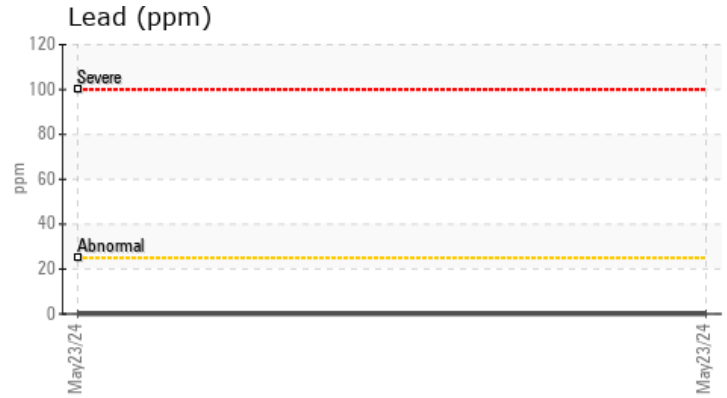
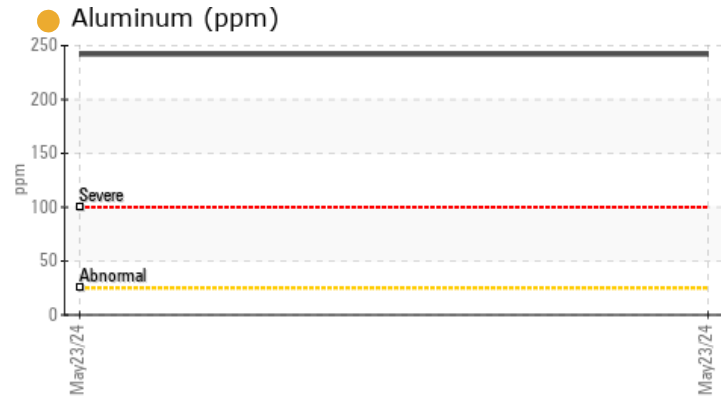
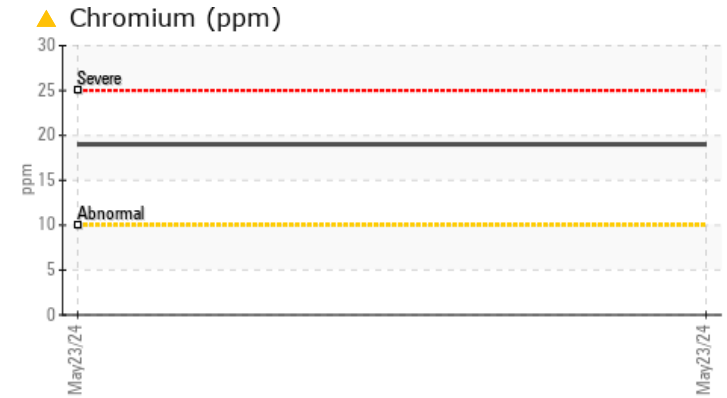
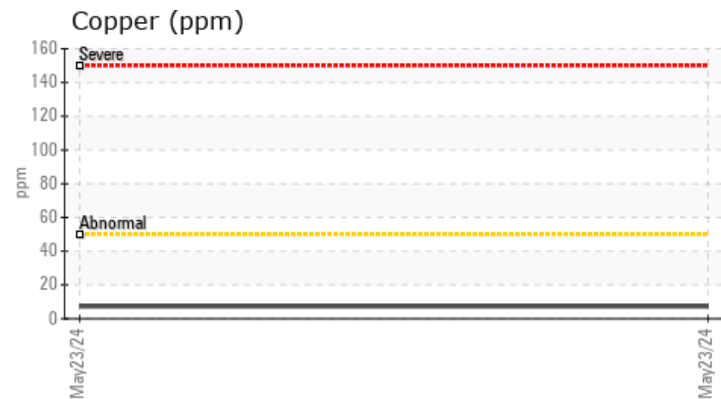
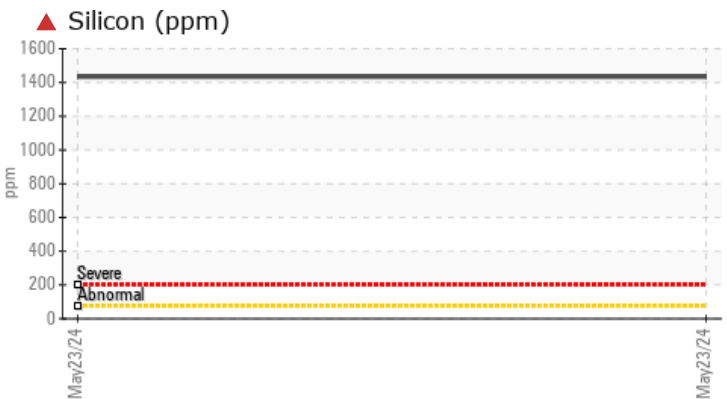
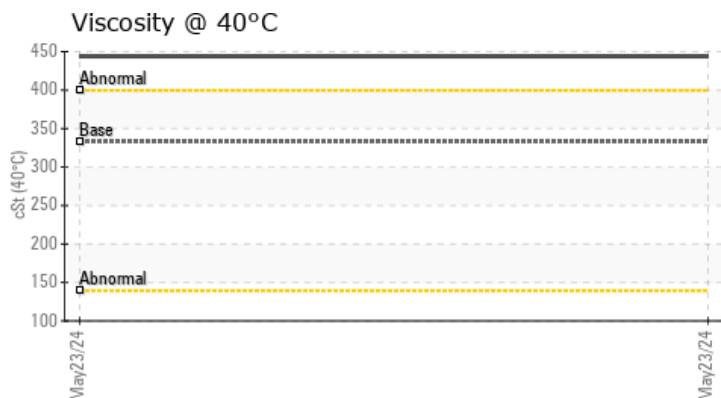
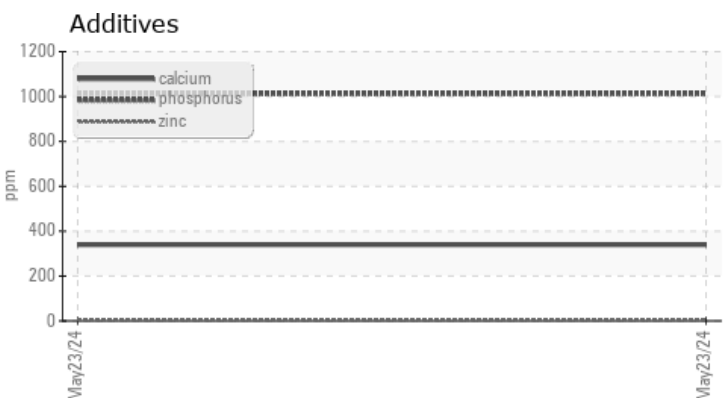
## VOLVO GRAPHS

We advise that you check all areas where dirt can enter the system. The oil change at the time of sampling has been noted. We advise that you inspect for the source(s) of wear. We recommend an early resample to monitor this condition. High concentration of visible metal present. Gear wear is indicated. Elemental levels of silicon (Si) and aluminum (Al) indicate alumina-silicate (coarse dirt) ingress. The oil is no longer serviceable due to the presence of contaminants.
