# PROBLEM SUMMARY

Machine Id  
**KAESER 7975796**

Component  
**Compressor**

# OIL ANALYSIS REPORT

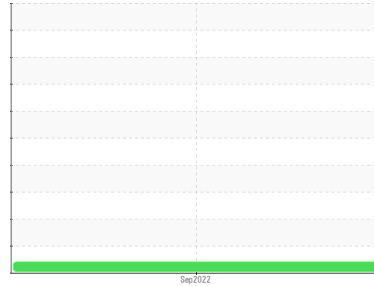
Sample Rating Trend

**VIS DEBRIS**

Sample Status				<b>ABNORMAL</b>	---	---
Debris	scalar	*Visual	NONE	<b>▲ MODER</b>	---	---

Oil and filter change at the time of sampling has been noted. Resample at the next service interval to monitor. We were unable to perform a particle count due to a high concentration of particles present in this sample.

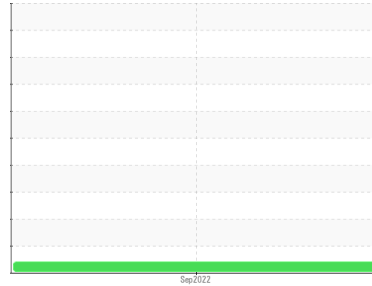
Sample Rating Trend

**VIS DEBRIS**

Moderate concentration of visible dirt/debris present in the oil.

Oil and filter change at the time of sampling has been noted. Resample at the next service interval to monitor. We were unable to perform a particle count due to a high concentration of particles present in this sample.
