MOBIL WEAR CHECK

OIL ANALYSIS REPORT

Machine Id
CATERPILLAR 24207283
Component
Diesel Engine
Fluid
{not provided} (--- GAL)

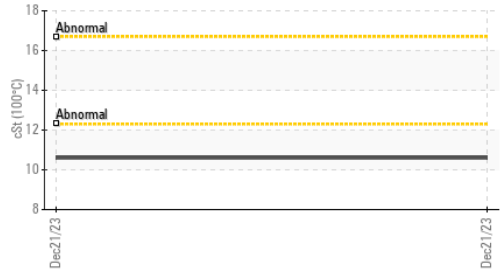
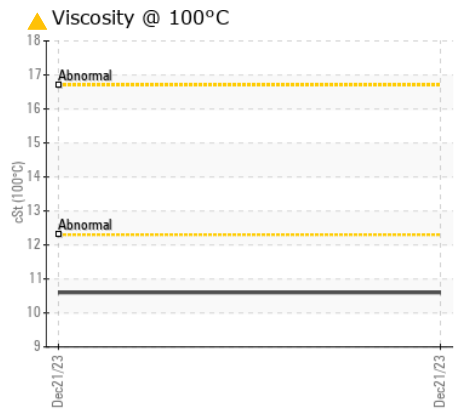
Viscosity @ 100°C

Fuel is present in the oil and is lowering the viscosity. The condition of the oil is acceptable for the time in service.

Resample at the next service interval to monitor. Please specify the brand, type, and viscosity of the oil on your next sample.

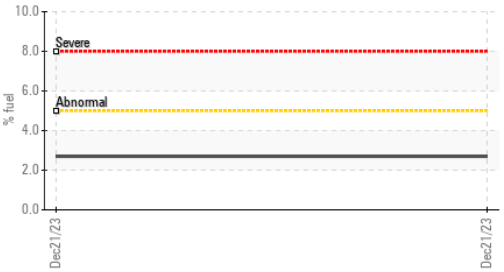
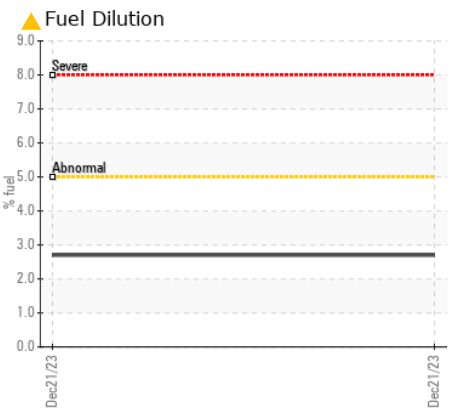
Fuel Dilution

Light fuel dilution occurring.

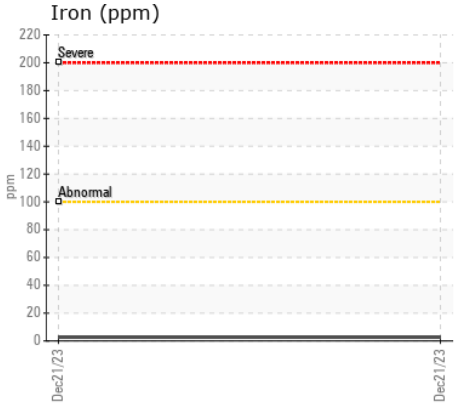
Iron (ppm)

All component wear rates are normal.
