MOB 1 WEAR CHECK

OIL ANALYSIS REPORT

Machine Id
MACLEAN SL3 SL06
Component
Hydraulic System
Fluid
AW HYDRAULIC OIL ISO 46 (--- GAL)

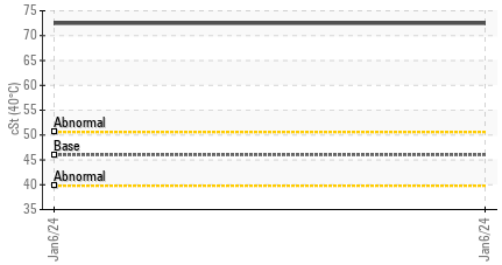
Viscosity @ 40°C

Viscosity of sample indicates oil is within SAE 30 range, advise investigate. This plus the additive levels indicates that this is not the same brand, or type of oil as reported. The condition of the oil is acceptable for the time in service.

Confirm the source of the lubricant being utilized for top-up/fill. Resample at the next service interval to monitor. Please contact your representative for information regarding the proper sampling kits for your service. NOTE: We recommend using MOB 2 test kits, this testkit includes Particle Count to determine the ISO cleanliness of the fluid.

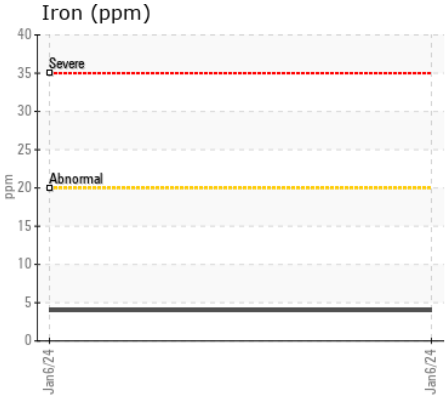
Iron (ppm)

All component wear rates are normal.

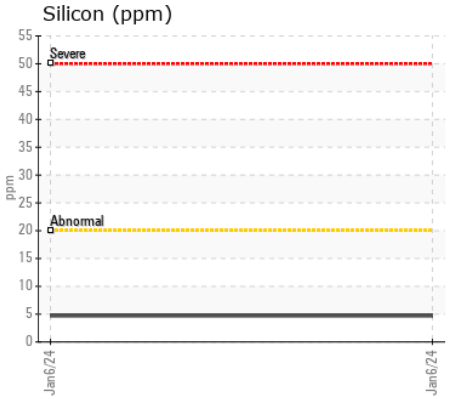
Silicon (ppm)

There is no indication of any contamination in the component(unconfirmed).
