OIL ANALYSIS REPORT

Area
[388594]
Machine Id
16-8016
Component
Transmission (Auto)
Fluid
VOLVO AUTOMATIC TRANSMISSION FLUID AT102 (--- GAL)

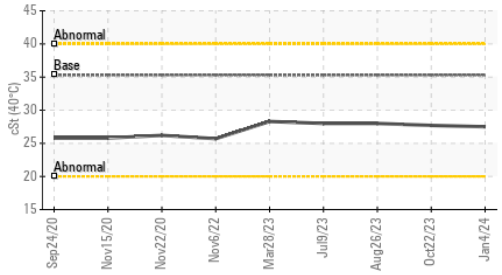
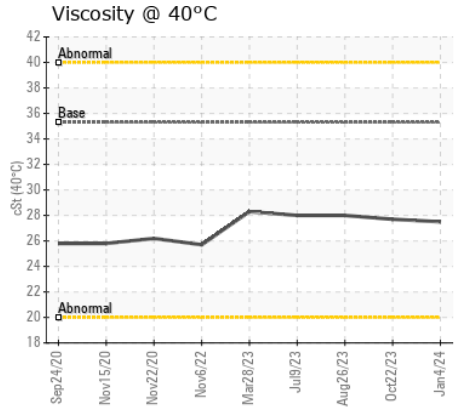
Viscosity @ 40°C

Additive levels indicate the addition of a different brand, or type of fluid.
The condition of the fluid is acceptable for the time in service.

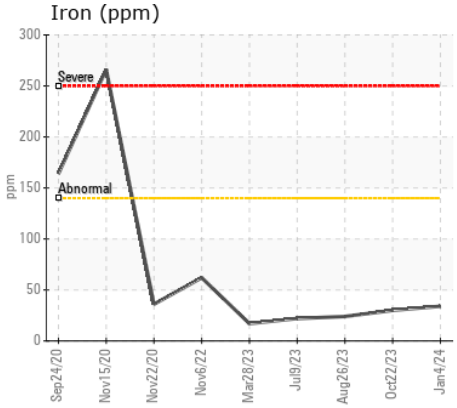
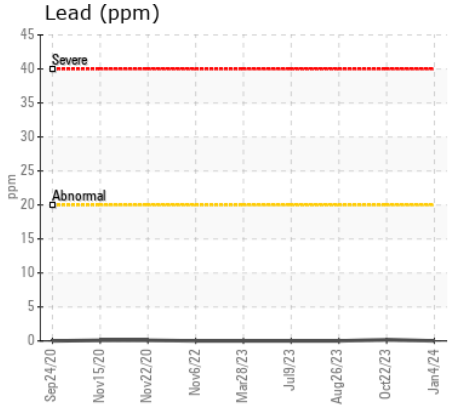
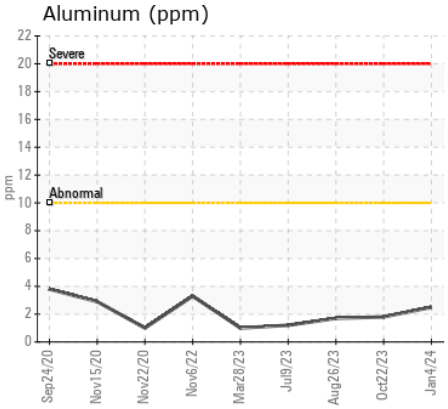
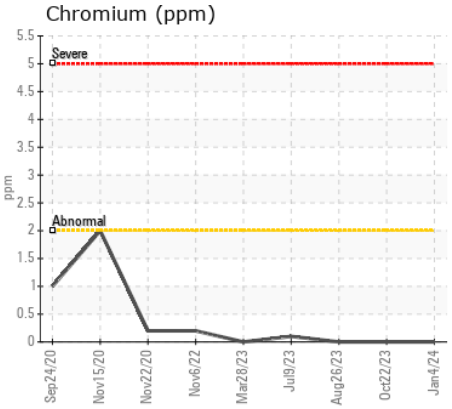
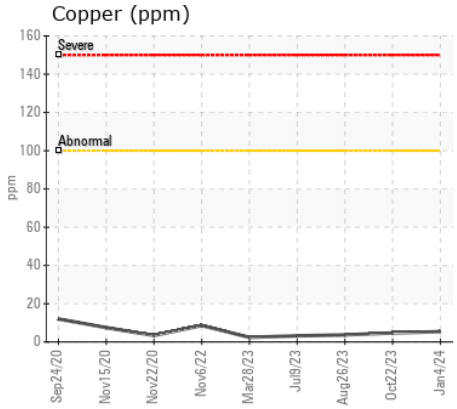
All component wear rates are normal.

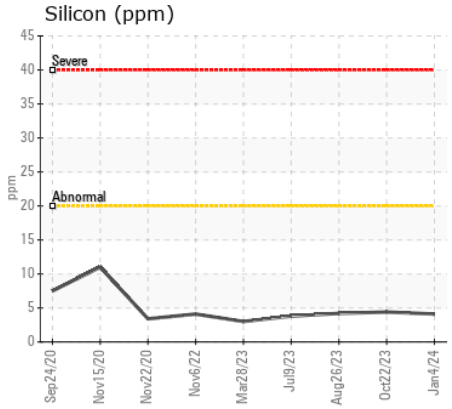
Silicon (ppm)

There is no indication of any contamination in the fluid.
