MOB II WEAR CHECK

# OIL ANALYSIS REPORT

Area
**QC Engine**
Machine Id
**QC230725MOB2**
Component
**Diesel Engine**
Fluid
**DIESEL ENGINE OIL SAE 40 (--- GAL)**

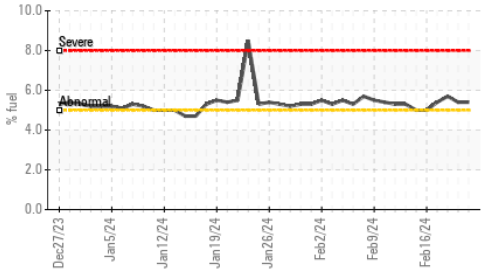
Fuel Dilution

There is a moderate amount of fuel present in the oil. There is a moderate concentration of water present in the oil. Tests confirm the presence of fuel in the oil.

| Test | UOM | Method | Limit/Abn | Current | History1 | History2 |
|---|---|---|---|---|---|---|
| Fuel | % | ASTM D7593* | >5 | ▲ 5.4 | ▲ 5.4 | ▲ 5.7 |

We advise that you check for the source of water entry. We recommend that you drain the oil from the component if this has not already been done. We recommend an early resample to monitor this condition. Please specify the component make and model with your next sample.

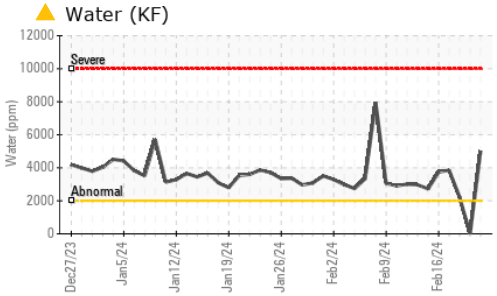
Water (KF)

| Test | UOM | Method | Limit/Abn | Current | History1 | History2 |
|---|---|---|---|---|---|---|
| Water | % | ASTM D6304* | >0.2 | ▲ 0.501 | --- | ▲ 0.221 |

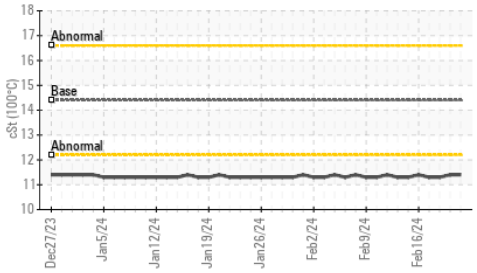
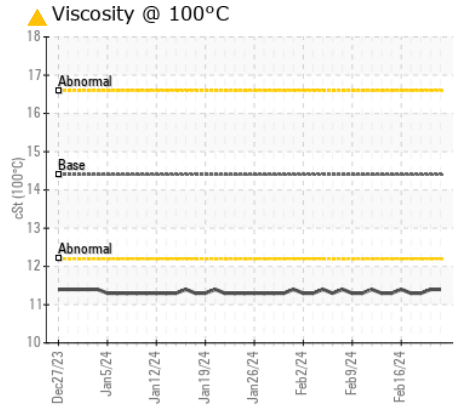
Viscosity @ 100°C

The BN result indicates that there is suitable alkalinity remaining in the oil. Viscosity of sample indicates oil is within SAE 10W30 range, advise investigate. The oil is no longer serviceable due to the presence of contaminants.

| Test | UOM | Method | Limit/Abn | Current | History1 | History2 |
|---|---|---|---|---|---|---|
| Visc @ 100°C | cSt | ASTM D7279(m) | 14.4 | ▲ 11.4 | ▲ 11.4 | ▲ 11.3 |

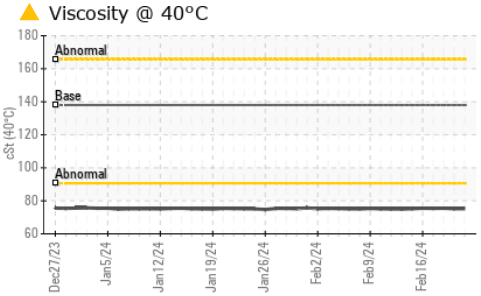
Viscosity @ 40°C

| Test | UOM | Method | Limit/Abn | Current | History1 | History2 |
|---|---|---|---|---|---|---|
| Visc @ 40°C | cSt | ASTM D7279(m) | 138 | ▲ 75.2 | ▲ 75.2 | ▲ 75.5 |

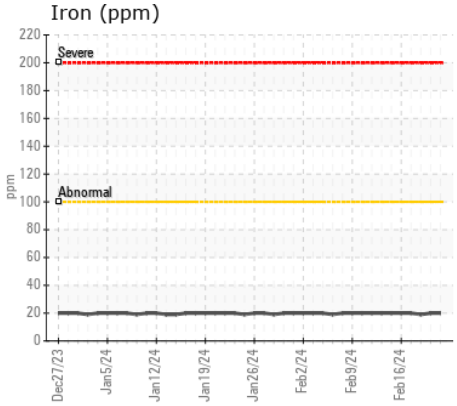
Iron (ppm)

All component wear rates are normal.
