MOBIL LUBE 360 OIL DIAGNOSTICS

OIL ANALYSIS REPORT

Machine Id
NO UNIT GFL0107915
Component
Diesel Engine
Fluid
{not provided} (--- GAL)

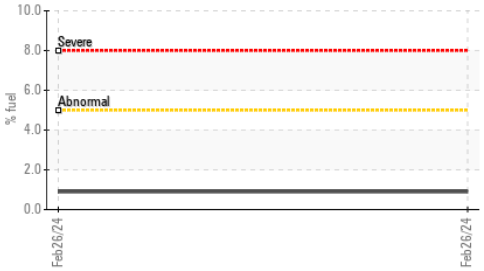
Fuel Dilution

Fuel content negligible. Elevated aluminum (Al) and/or lead (Pb) and potassium (K) levels in your metals analysis are likely a result of solder flux release into the lubricant and is common on new equipment/components. There is no indication of any contamination in the oil.

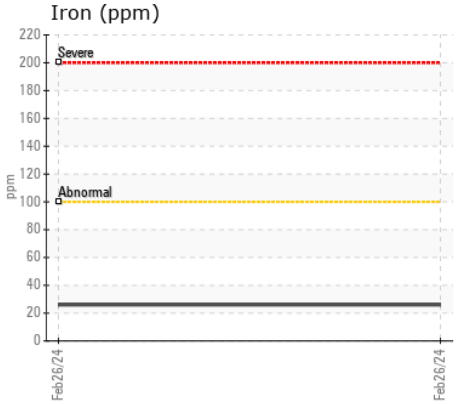
Iron (ppm)

All component wear rates are normal.

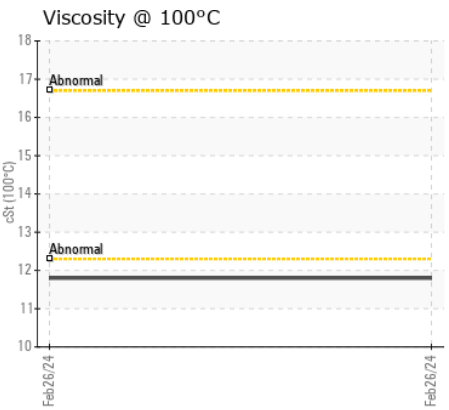
Viscosity @ 100°C

Viscosity of sample indicates oil is within SAE 30 range, advise investigate. The condition of the oil is acceptable for the time in service.
