OIL ANALYSIS REPORT

Area
[397276]
Machine Id
16-8019
Component
Transmission (Auto)
Fluid
VOLVO AUTOMATIC TRANSMISSION FLUID AT102 (--- GAL)

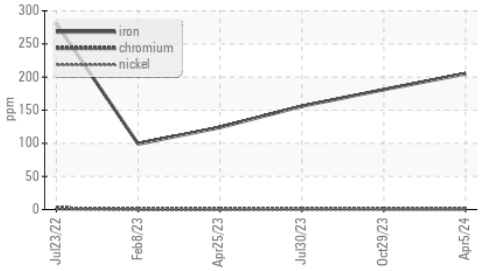
Ferrous Alloys

Iron ppm levels are abnormal. The low ferrous density (PQ) index indicates the wear metal levels are due to corrosion.

We recommend that you drain the fluid from the component if this has not already been done. Confirm the source of the lubricant being utilized for top-up/fill. We recommend an early resample to monitor this condition.

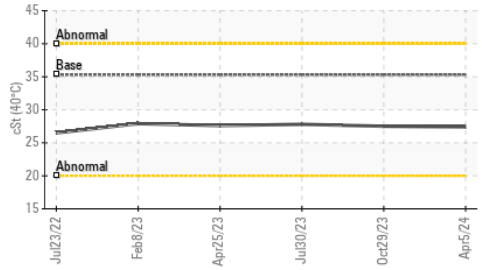
Viscosity @ 40°C

Additive levels indicate the addition of a different brand, or type of fluid. The fluid is no longer serviceable as a result of the abnormal and/or severe wear.
