OIL ANALYSIS REPORT

Machine Id
236279
Component
Diesel Engine
Fluid
{not provided} (--- GAL)

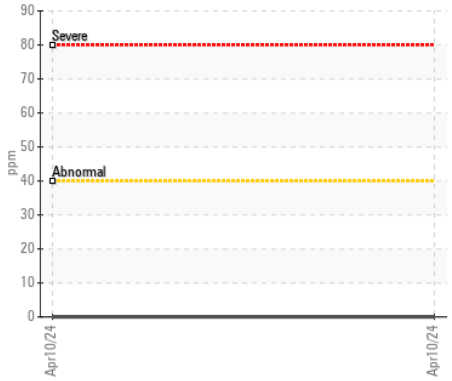
Lead (ppm)

Elevated aluminum (Al) and/or lead (Pb) and potassium (K) levels in your metals analysis are likely a result of solder flux release into the lubricant and is common on new equipment/components. There is no indication of any contamination in the oil.
