MOB LUBE 360 OIL DIAGNOSTICS

OIL ANALYSIS REPORT

Machine Id
713072
Component
Hydraulic System
Fluid
PETRO CANADA HYDREX MV 32 (--- GAL)

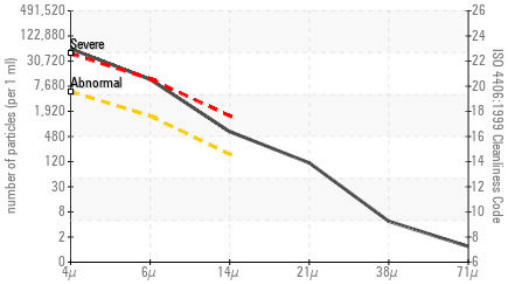
Particle Count

Il y a une quantité élevée de matières particulaires (2 à 100 µm de taille) présente dans l'huile.

Water		WC Method	>0.1	NEG	NEG	NEG
Particles >4µm		ASTM D7647	>5000	▲ 52202	▲ 59352	▲ 74170
Particles >6µm		ASTM D7647	>1300	▲ 9691	▲ 6848	▲ 8283
Particles >14µm		ASTM D7647	>160	▲ 551	● 235	105
Particles >21µm		ASTM D7647	>40	▲ 99	● 67	22
Particles >38µm		ASTM D7647	>10	4	9	1
Particles >71µm		ASTM D7647	>3	1	1	0
Oil Cleanliness		ISO 4406 (c)	>19/17/14	▲ 23/20/16	▲ 23/20/15	▲ 23/20/14
Silt	scalar	Visual*	NONE	NONE	NONE	NONE
Debris	scalar	Visual*	NONE	VLITE	VLITE	NONE
Sand/Dirt	scalar	Visual*	NONE	NONE	VLITE	NONE
Appearance	scalar	Visual*	NORML	NORML	NORML	NORML
Odor	scalar	Visual*	NORML	NORML	NORML	NORML
Emulsified Water	scalar	Visual*	>0.1	NEG	NEG	NEG
Sodium	ppm	ASTM D5185(m)		3	3	3
Boron	ppm	ASTM D5185(m)	0	<1	<1	<1
Barium	ppm	ASTM D5185(m)	0	0	0	0
Molybdenum	ppm	ASTM D5185(m)	0	0	0	0
Manganese	ppm	ASTM D5185(m)	1	0	0	0
Magnesium	ppm	ASTM D5185(m)	0	2	2	3
Calcium	ppm	ASTM D5185(m)	50	291	297	620
Phosphorus	ppm	ASTM D5185(m)	330	276	273	230

Nous vous recommandons de vérifier tous les endroits par lesquels des contaminants peuvent pénétrer dans le système. Nous vous recommandons de remplacer le filtre et d'utiliser un système de filtrage hors-ligne afin d'améliorer la propreté du fluide. Le reniflard d`air doit être réparé. S`il n`est pas classé, nous vous recommandons de le remplacer par un reniflard à air adapté au micron et / ou au dessicant. Si évalué, nous vous recommandons de réparer / remplacer le reniflard. Échantillonner de nouveau dans 30 à 45 jours afin de contrôler la situation.

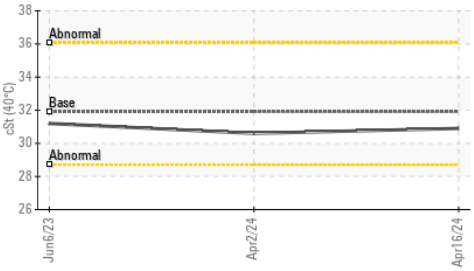
Viscosity @ 40°C

l'huile peut encore servir si la contamination peut être réduite à un niveau acceptable.

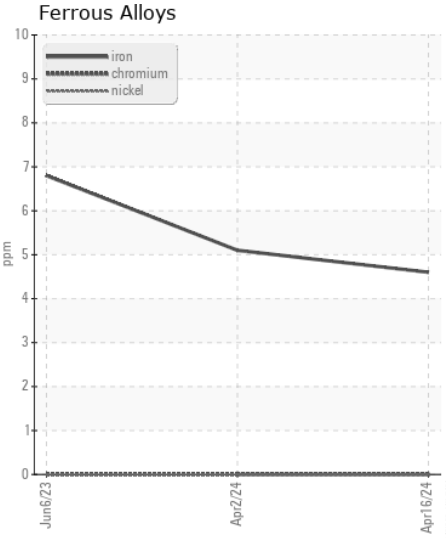
Ferrous Alloys

Les taux d'usure de tous les composants sont normaux.
