OIL ANALYSIS REPORT

Area
[402213]
Machine Id
16-8019
Component
Transmission (Auto)
Fluid
VOLVO AUTOMATIC TRANSMISSION FLUID AT102 (--- GAL)

Report Id: HOLCON [WCAMIS] 02631359 (Generated: 04/26/2024 07:59:40) Rev: 1

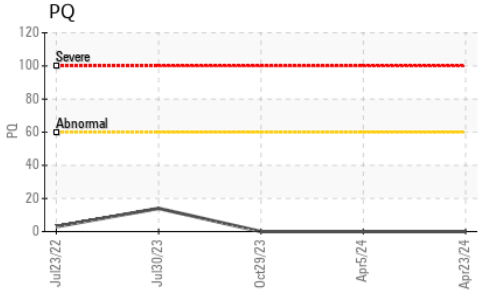
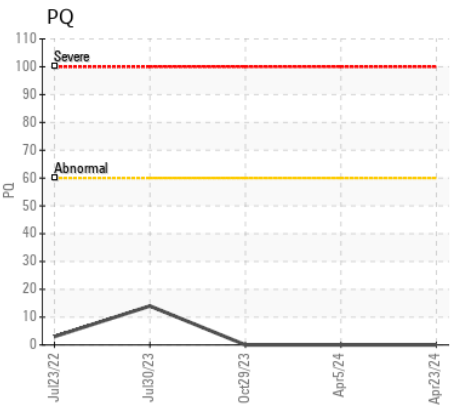
PQ

Iron ppm levels are abnormal. The low ferrous density (PQ) index indicates the wear metal levels are due to corrosion.

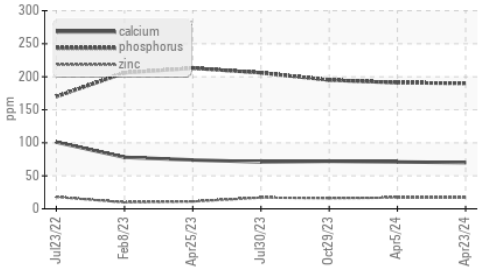
Additives

Additive levels indicate the addition of a different brand, or type of fluid. The fluid is no longer serviceable as a result of the abnormal and/or severe wear.

We recommend that you drain the fluid from the component if this has not already been done. Confirm the source of the lubricant being utilized for top-up/fill. We recommend an early resample to monitor this condition.
