OIL ANALYSIS REPORT

Area
[155075]
Machine Id
77289560
Component
Diesel Engine
Fluid
DIESEL ENGINE OIL SAE 40 (--- GAL)

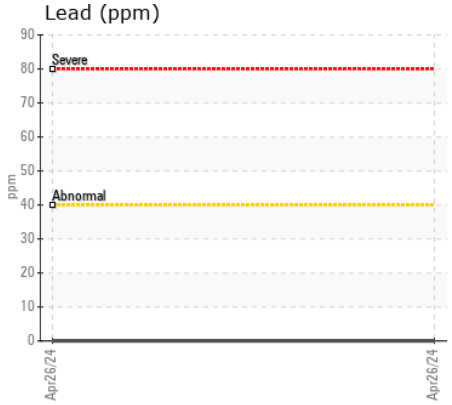
Lead (ppm)

Elevated aluminum (Al) and/or lead (Pb) and potassium (K) levels in your metals analysis are likely a result of solder flux release into the lubricant and is common on new equipment/components. There is no indication of any contamination in the oil.
