MOBIL LUBE 360 OIL DIAGNOSTICS

OIL ANALYSIS REPORT

Area
MICHAUDVILLE [P-28604]
Machine Id
1523
Component
Diesel Engine
Fluid
{not provided} (--- GAL)

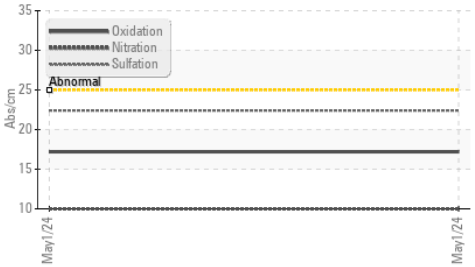
FT-IR (Direct Trend)

Elevated aluminum (Al) and/or lead (Pb) and potassium (K) levels in your metals analysis are likely a result of solder flux release into the lubricant and is common on new equipment/components. Tests indicate that there is no fuel present in the oil. There is no indication of any contamination in the oil.

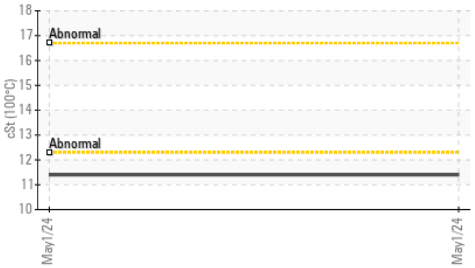
Viscosity @ 100°C

Viscosity of sample indicates oil is within SAE 10W30 range, advise investigate. The condition of the oil is acceptable for the time in service.

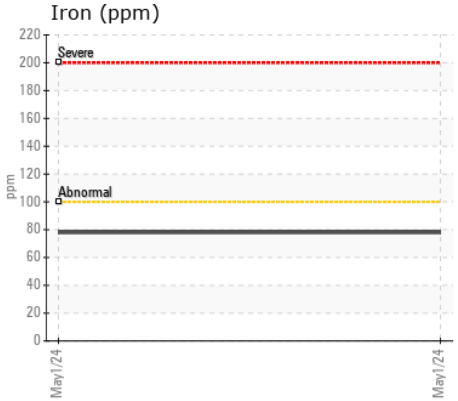
Iron (ppm)

Metal levels are typical for a new component breaking in.
