MOBIL LUBE 360 OIL DIAGNOSTICS

OIL ANALYSIS REPORT

Area
GFL218
Machine Id
714032
Component
Diesel Engine
Fluid
{not provided} (--- GAL)

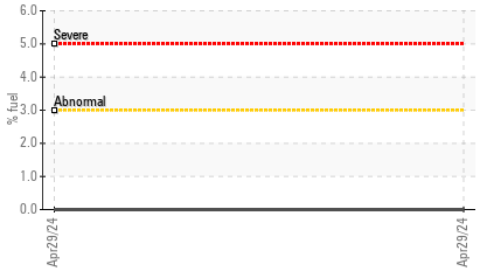
Fuel Dilution

Elevated aluminum (Al) and/or lead (Pb) and potassium (K) levels in your metals analysis are likely a result of solder flux release into the lubricant and is common on new equipment/components. Tests indicate that there is no fuel present in the oil. There is no indication of any contamination in the oil.

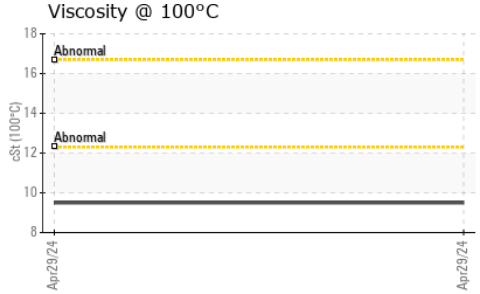
Viscosity @ 100°C

Viscosity of sample indicates oil is within SAE 30 range, advise investigate. The condition of the oil is acceptable for the time in service.

Resample at the next service interval to monitor. The fluid was not specified, however, a fluid match indicates that this fluid is SAE 30 Diesel Engine Oil. Please confirm the oil type and grade, and specify the brand of the oil on your next sample.

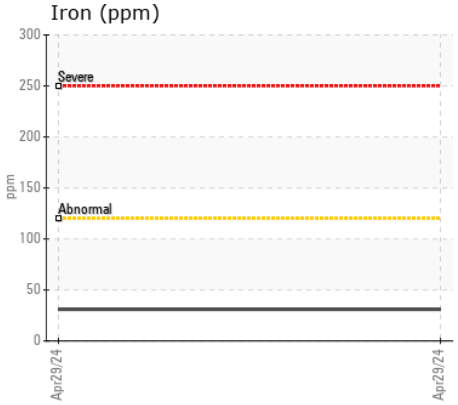
Iron (ppm)

Metal levels are typical for a new component breaking in.
