OIL ANALYSIS REPORT

Area
[85836]
Machine Id
5539 MT ALBERT RD, MT ALBERT #4502754 BELL CANADA U590576K
Component
Rear Diesel Engine
Fluid
ESSO XD-3 EXTRA 15W40 (10 LTR)

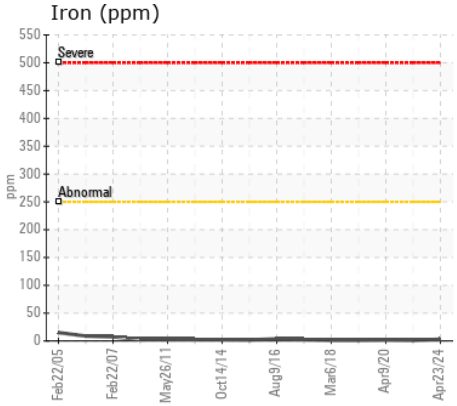
Iron (ppm)

Metal levels are typical for a new component breaking in.

Resample at the next service interval to monitor.
