OIL ANALYSIS REPORT

Area
SAB1
Machine Id
SAB1 G1
Component
Turbine Bearing
Fluid
ESSO TERESSO ISO 46 (150 LTR)

Ontario Power Generation
NIAGARA PLANT GROUP,, 14000 NIAGARA PKWY
NIAGARA ON THE LAKE, ON
CA L0S 1J0
Contact: Michael Brochu
mike.brochu@opg.com
T: (905)357-0322
F: (905)374-5466

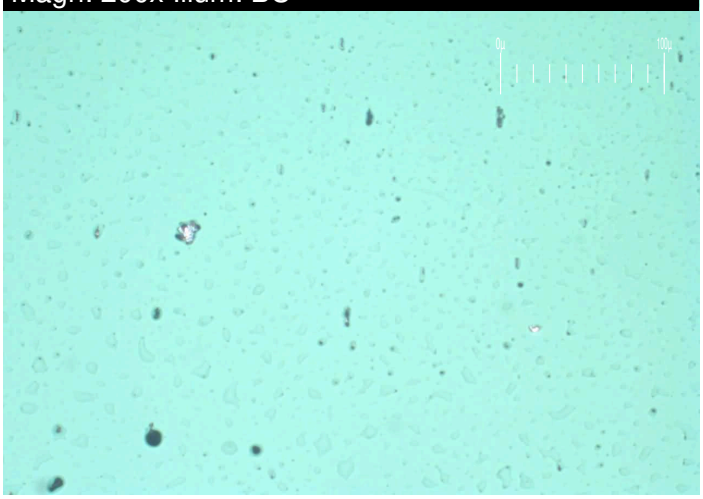
All component wear rates are normal. The ferrography results are normal indicating no abnormal wear in the system.

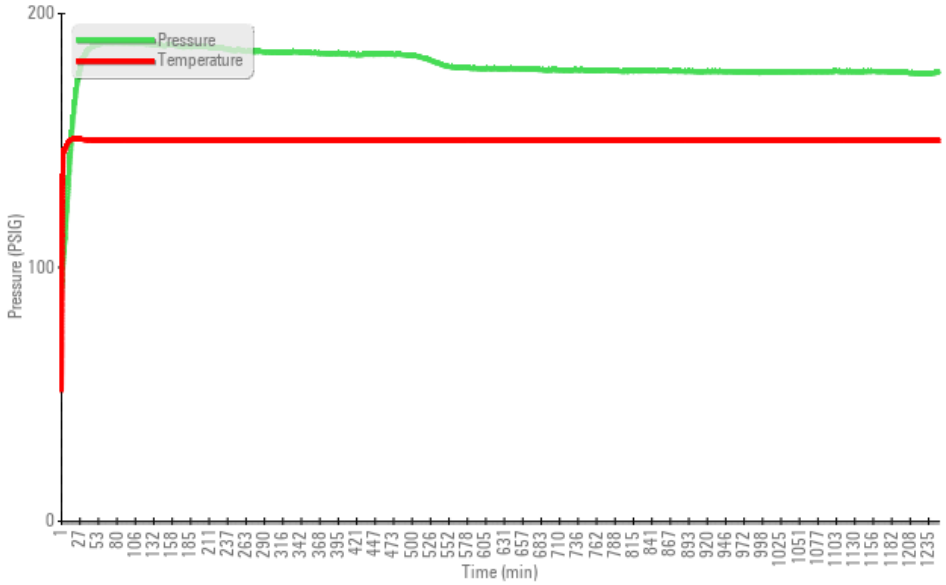
Rotating Pressure Vessel Oxidation Test

Oxidation Test (RPVOT)	minutes	ASTM D2272*	600	**2251**	---	---
Anti-Oxidant 1	%	ASTM D6971*	<25	**100**	---	---
Anti-Oxidant 2	%	ASTM D6971*	<25	**54**	---	---
Lubricant Degradation	Scale 0-10	ASTM D7684*

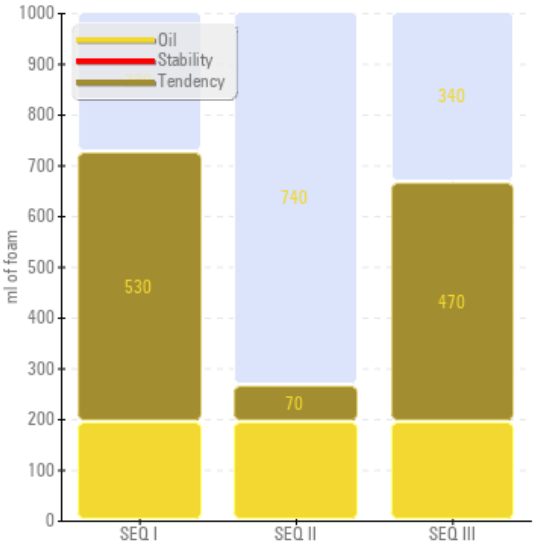
Foaming SEQ I/II/III

Foaming Tendency (ASTM D892) results are abnormal indicating a tendency for oil foaming. Rust Prevention test (ASTM D665) indicates the oil retains good anti-corrosion properties. The AN level is acceptable for this fluid.

We recommend that you perform vacuum distillation and/or air drying to attempt to remove any residual water and/or entrained gases from this oil that may be contributing to abnormal foaming and/or poor water separability. We recommend an early resample to monitor this condition.
