WEAR CHECK

OIL ANALYSIS REPORT

Area
SAB1
Machine Id
SAB1 G1
Component
Thrust Bearing
Fluid
ESSO TERESSO ISO 46 (4250 LTR)

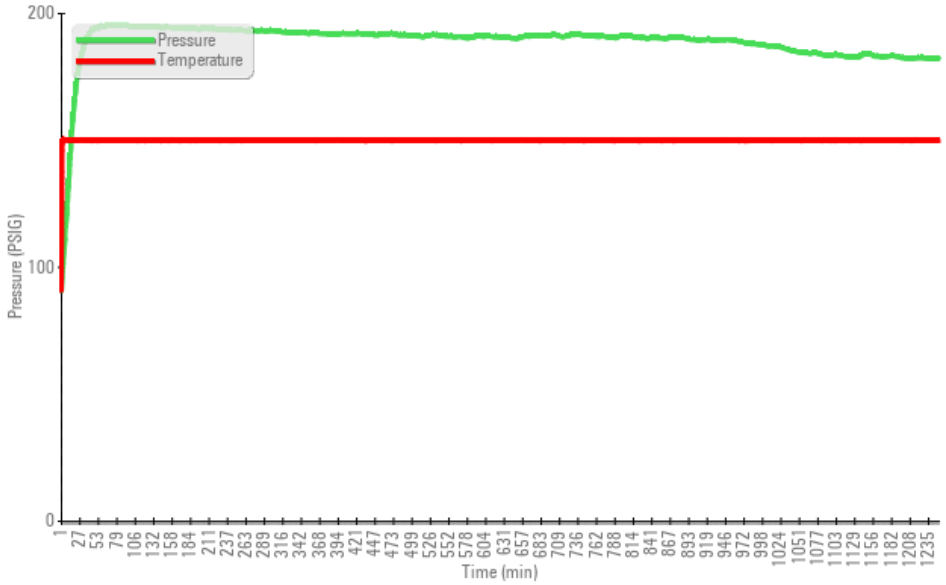
Rotating Pressure Vessel Oxidation Test

Oxidation Test (RPVOT)	minutes	ASTM D2272*	600	**3212**	---	---
Anti-Oxidant 1	%	ASTM D6971*	<25	**100**	---	---
Anti-Oxidant 2	%	ASTM D6971*	<25	**37**	---	---
Lubricant Degradation	Scale 0-10	ASTM D7684*

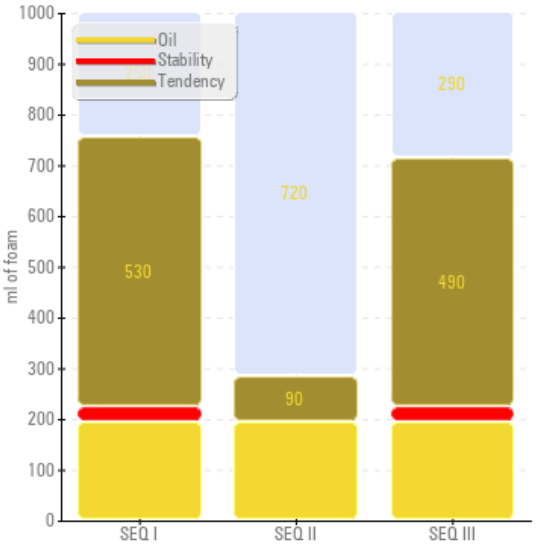
Foaming SEQ I/II/III

Foaming Stability (ASTM D892) results are abnormal indicating an oil foaming problem that could lead to erratic operation. Rust Prevention test (ASTM D665) indicates the oil retains good anti-corrosion properties. The AN level is acceptable for this fluid.

We recommend that you perform vacuum distillation and/or air drying to attempt to remove any residual water and/or entrained gases from this oil that may be contributing to abnormal foaming and/or poor water separability. We recommend that you investigate the system for introduction of a surfactant to the reservoir. Some potential surfactants include incorrect oil make-up with an oil containing emulsifying agents (engine oil, compressor oil, gear oil), or soaps entering the system after wash down. We recommend an early resample to monitor this condition. Suspect this is Petro-Canada Turboflo XL 46. Please confirm oil type.

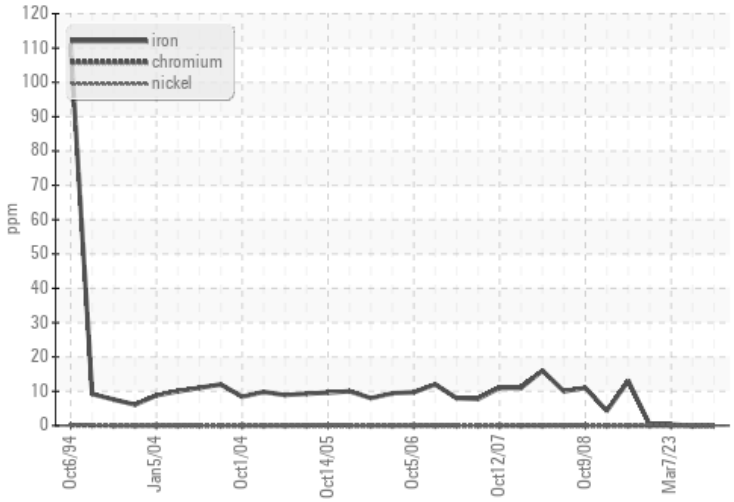
Ferrous Alloys

All component wear rates are normal. The ferrography results are normal indicating no abnormal wear in the system.
