OIL ANALYSIS REPORT

Area
[86395]
Machine Id
1 ADELAIDE ST E TORONTO GWL GWL
Component
Right Diesel Engine
Fluid
ESSO XD-3 EXTRA 15W40 (100 GAL)

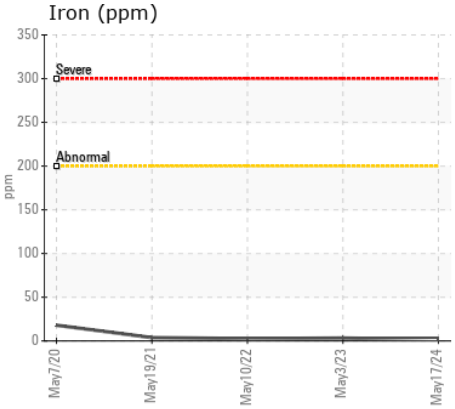
Iron (ppm)

Metal levels are typical for a new component breaking in. Component wear rates appear to be normal (unconfirmed).

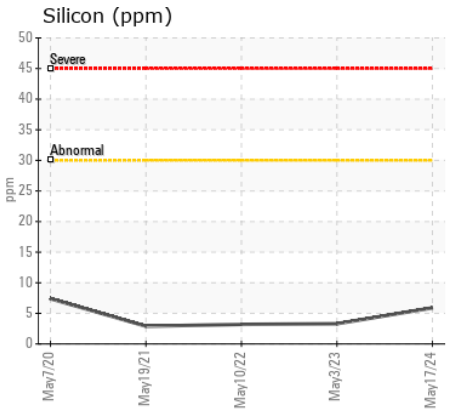
Silicon (ppm)

There is no indication of any contamination in the oil.

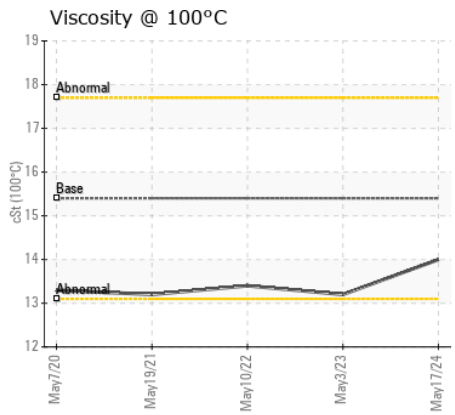
Viscosity @ 100°C

The condition of the oil is acceptable for the time in service (unconfirmed).
