OIL ANALYSIS REPORT

Machine Id
JOHN DEERE 223-1004
Component
Hydraulic System
Fluid
SAE 15W40 (--- GAL)

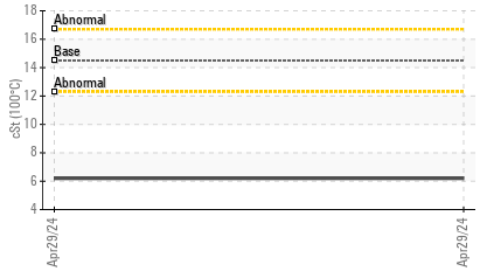
Viscosity @ 100°C

Viscosity of sample indicates oil is within SAE 20 range, advise investigate. The condition of the oil is acceptable for the time in service.

Resample at the next service interval to monitor. Please contact your representative for information regarding the proper sampling kits for your service. NOTE: We recommend using MOB 2 test kits, this testkit includes Particle Count to determine the ISO cleanliness of the fluid.
