MOBIL LUBE 360 OIL DIAGNOSTICS

OIL ANALYSIS REPORT

Machine Id
OE444
Component
Transmission (Auto)
Fluid
TES SYN 295 (--- GAL)

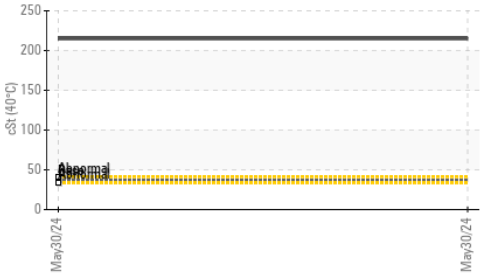
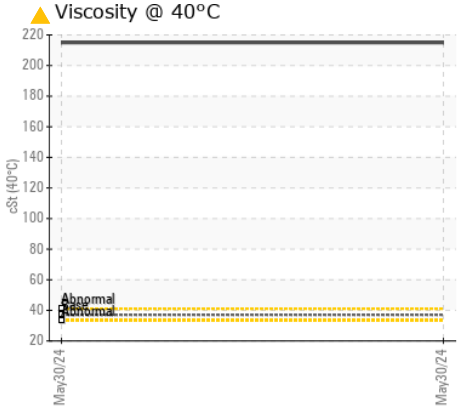
Viscosity @ 40°C

Viscosity of sample indicates oil is within ISO 220 range, advise investigate. This plus the additive levels indicates that this is not the same brand, or type of oil as reported. The condition of the fluid is acceptable for the time in service.

Confirm the source of the lubricant being utilized for top-up/fill. Resample at the next service interval to monitor.

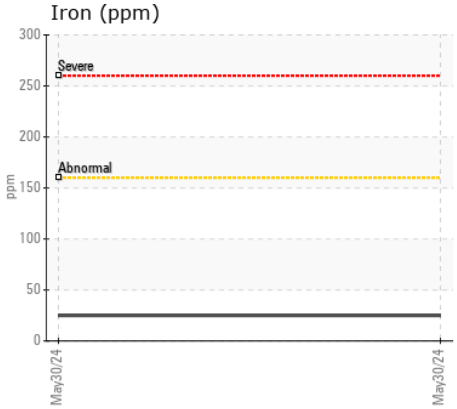
Iron (ppm)

All component wear rates are normal.

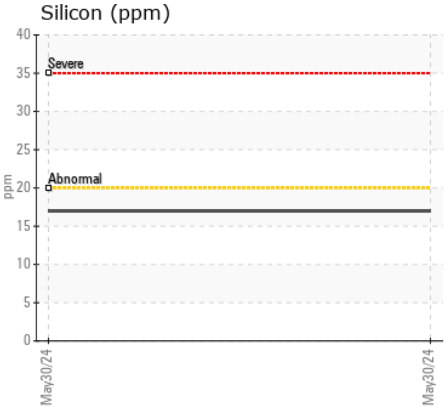
Silicon (ppm)

There is no indication of any contamination in the fluid.
