MOB LUBE 360 OIL DIAGNOSTICS

OIL ANALYSIS REPORT

Machine Id
113006
Component
Diesel Engine
Fluid
PETRO CANADA DURON SAE 10W30 (--- GAL)

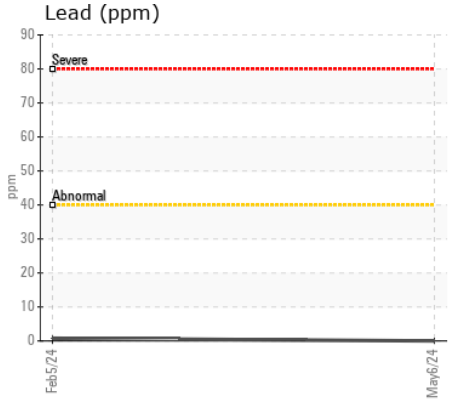
Lead (ppm)

Elevated aluminum (Al) and/or lead (Pb) and potassium (K) levels in your metals analysis are likely a result of solder flux release into the lubricant and is common on new equipment/components. There is no indication of any contamination in the oil.
