OIL ANALYSIS REPORT

Area
COGECO [156393]
Machine Id
16601001362
Component
Diesel Engine
Fluid
VALVOLINE 15W40 (--- GAL)

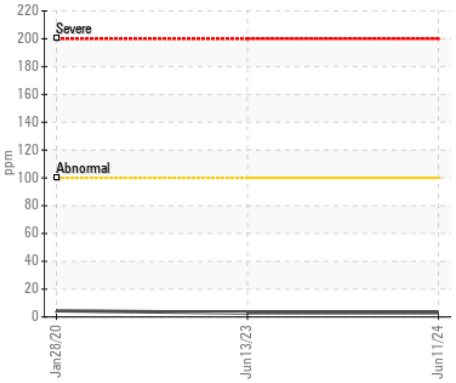
Iron (ppm)

Metal levels are typical for a new component breaking in.

Resample at the next service interval to monitor.

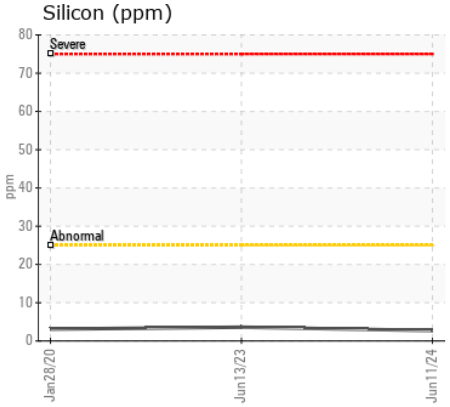
Silicon (ppm)

There is no indication of any contamination in the oil.

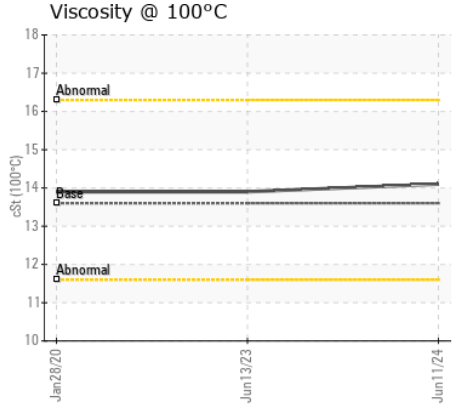
Viscosity @ 100°C

The condition of the oil is acceptable for the time in service.
