MOB II WEAR CHECK

OIL ANALYSIS REPORT

Machine Id
QC230725MOB2
Component
Diesel Engine
Fluid
DIESEL ENGINE OIL SAE 40 (--- GAL)

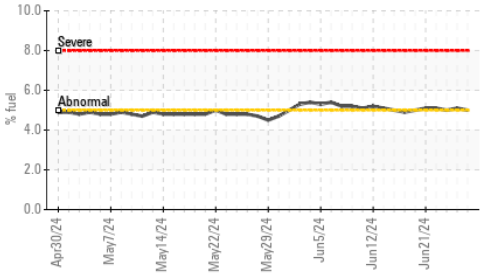
Fuel Dilution

There is a moderate amount of fuel present in the oil. There is a light concentration of water present in the oil. Tests confirm the presence of fuel in the oil.

We advise that you check for the source of water entry. We recommend that you drain the oil from the component if this has not already been done. We recommend you service the filters on this component. We recommend an early resample to monitor this condition. Please specify the component make and model with your next sample.

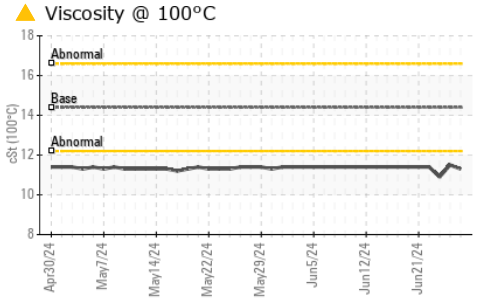
Viscosity @ 100°C

The BN result indicates that there is suitable alkalinity remaining in the oil. Viscosity of sample indicates oil is within SAE 10W30 range, advise investigate. The oil is no longer serviceable due to the presence of contaminants.
