OIL ANALYSIS REPORT

Area
[F&B CONCRETE]
Machine Id
JOHN DEERE 1T0325GKJNJ421438
Component
Diesel Engine
Fluid
JOHN DEERE ENGINE OIL PLUS 50 II 0W40 (--- GAL)

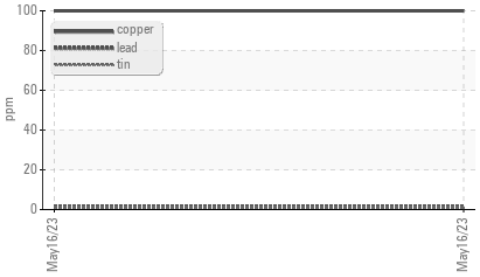
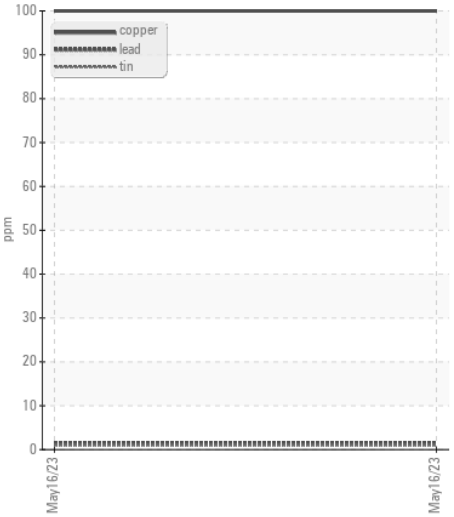
Non-ferrous Metals

The copper level is abnormal. In the absence of other significant wear metals, suspect copper due to sources other than wear (i.e. cooling core). All other metal levels are typical for a new component breaking in.

Oil and filter change at the time of sampling has been noted. Resample at the next service interval to monitor.

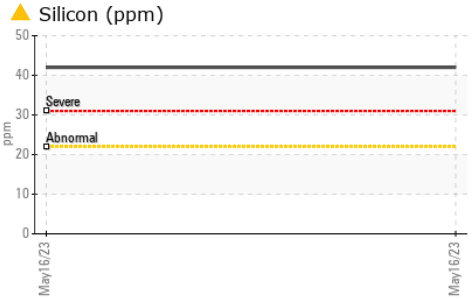
Silicon (ppm)

Elemental level of silicon (Si) above normal indicating ingress of seal material. Light fuel dilution occurring.

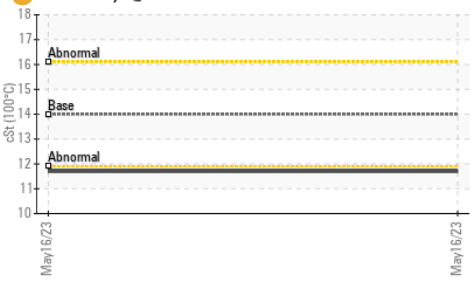
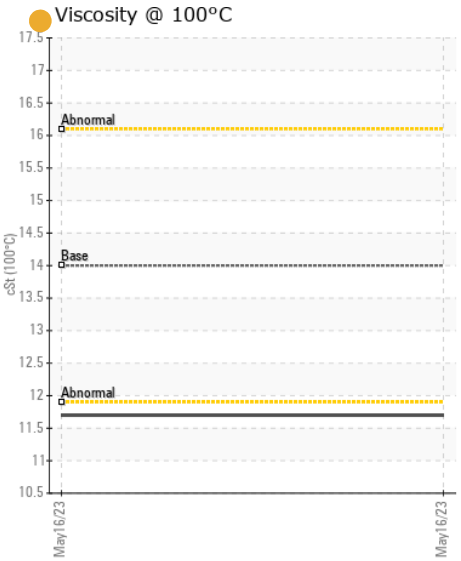
Viscosity @ 100°C

The oil viscosity is lower than normal. The BN result indicates that there is suitable alkalinity remaining in the oil.
