OIL ANALYSIS REPORT

Machine Id
JOHN DEERE 700L 1T0700LXTPF450323
Component
Diesel Engine
Fluid
{not provided} (--- GAL)

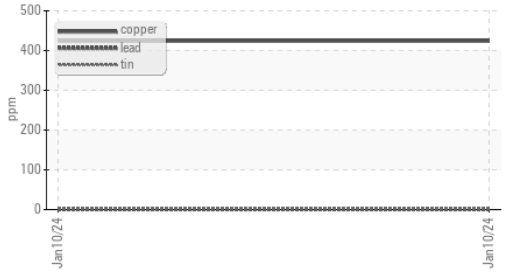
Non-ferrous Metals

The copper level is abnormal. In the absence of other significant wear metals, suspect copper due to sources other than wear (i.e. cooling core). All other metal levels are typical for a new component breaking in.

No corrective action is recommended at this time. Resample at the next service interval to monitor. Please specify the brand, type, and viscosity of the oil on your next sample.

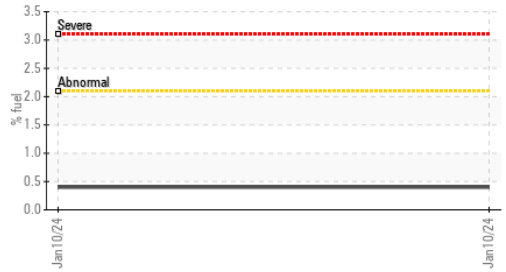
Fuel Dilution

Fuel content negligible. There is no indication of any contamination in the oil.

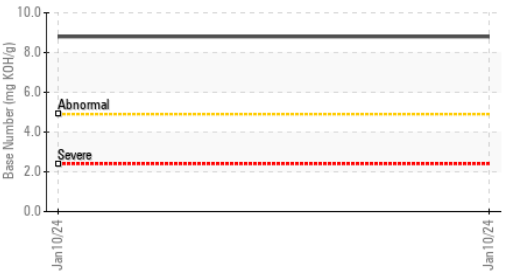
Base Number

The BN result indicates that there is suitable alkalinity remaining in the oil. The condition of the oil is suitable for further service.
