IDEALEASE FLEET

OIL ANALYSIS REPORT

Machine Id
42320
Component
Diesel Engine
Fluid
VALVOLINE 15W40 (--- GAL)

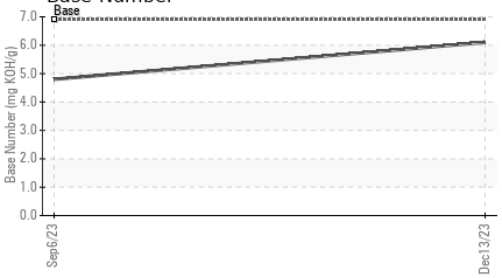
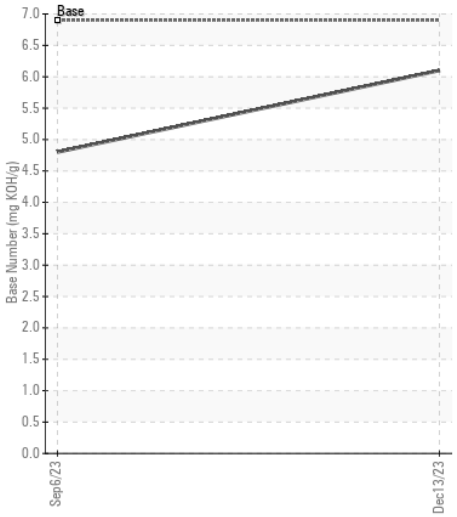
Base Number

The BN result indicates that there is suitable alkalinity remaining in the oil. The condition of the oil is suitable for further service.

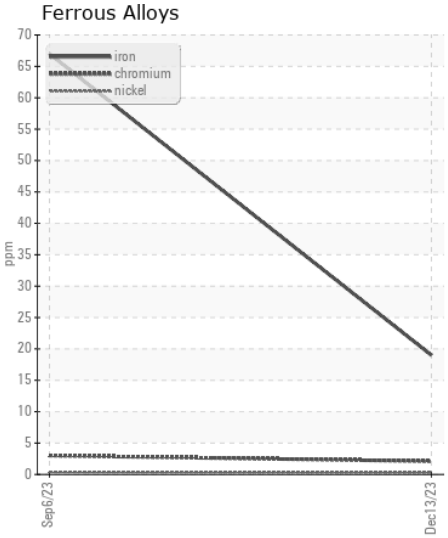
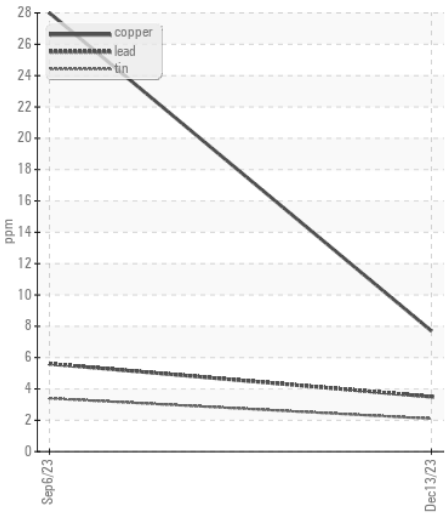
Ferrous Alloys

Metal levels are typical for a new component breaking in.

Resample at the next service interval to monitor. Please specify the component make and model with your next sample.
