OIL ANALYSIS REPORT

Machine Id
2406
Component
Diesel Engine
Fluid
ROYAL PURPLE MOTOR OIL 15W40 (--- QTS)

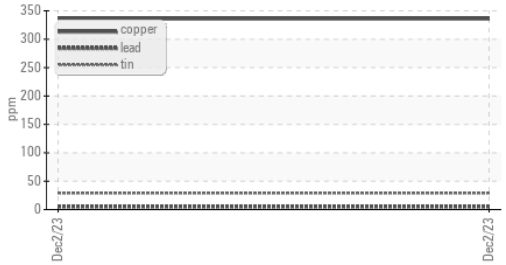
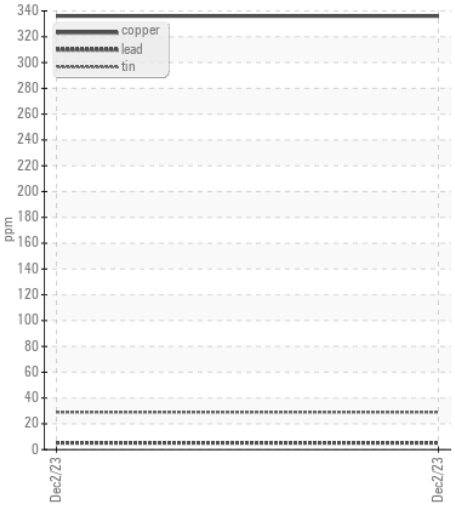
Non-ferrous Metals

The copper level is abnormal. In the absence of other significant wear metals, suspect copper due to sources other than wear (i.e. cooling core). All other component wear rates are normal.

No corrective action is recommended at this time. Resample at the next service interval to monitor.

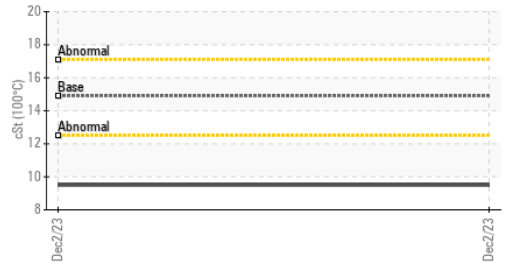
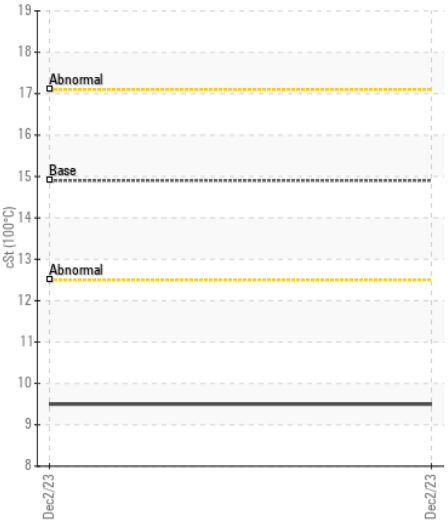
Viscosity @ 100°C

The oil viscosity is lower than normal. The BN result indicates that there is suitable alkalinity remaining in the oil. Confirm oil type.

Visc @ 100°C	cSt	ASTM D445	14.9	▲ 9.5	---	---

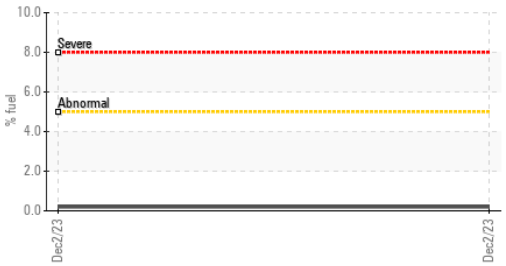
Fuel Dilution

Fuel content negligible. Elevated aluminum (Al) and/or lead (Pb) and potassium (K) levels in your metals analysis are likely a result of solder flux release into the lubricant and is common on new equipment/components.
