OIL ANALYSIS REPORT

Area
[SPM659560-10]
Machine Id
KPI FT42500C 420623
Component
Diesel Engine
Fluid
{not provided} (--- GAL)

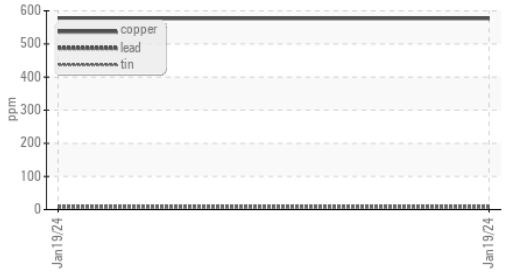
Non-ferrous Metals

The copper level is abnormal. In the absence of other significant wear metals, suspect copper due to sources other than wear (i.e. cooling core). All other metal levels are typical for a new component breaking in.

The oil change at the time of sampling has been noted. Resample at the next service interval to monitor. Please specify the brand, type, and viscosity of the oil on your next sample.

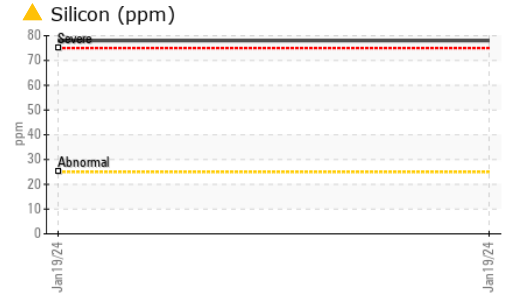
Silicon (ppm)

Fuel content negligible. Elemental level of silicon (Si) above normal indicating ingress of seal material.

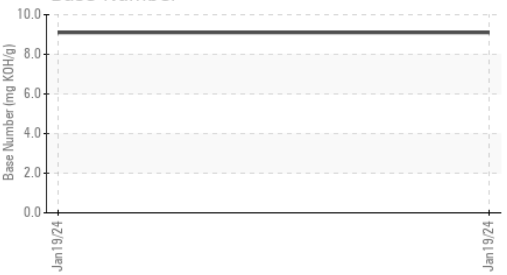
Base Number

The BN result indicates that there is suitable alkalinity remaining in the oil. The condition of the oil is acceptable for the time in service.
