# OIL ANALYSIS REPORT

Machine Id
## PETERBILT 846-4608
Component
## Diesel Engine
Fluid
## MOBIL DELVAC 1 5W40 (--- QTS)

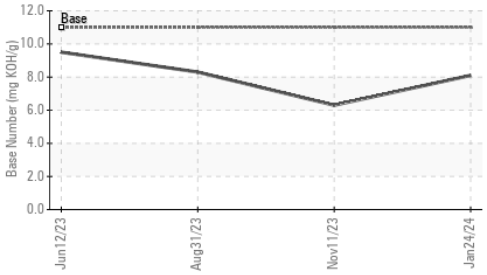
Base Number

The BN result indicates that there is suitable alkalinity remaining in the oil. The condition of the oil is suitable for further service.

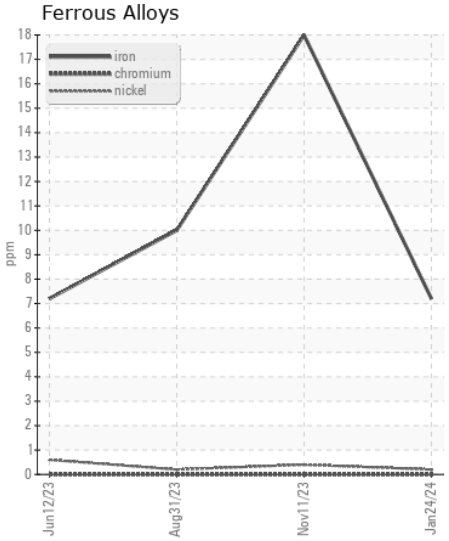
Ferrous Alloys

All component wear rates are normal.
