FLEET LUBE 360 OIL DIAGNOSTICS

# OIL ANALYSIS REPORT

Machine Id
**723022-361626**
Component
**Diesel Engine**
Fluid
**PETRO CANADA DURON SHP 15W40 (--- GAL)**

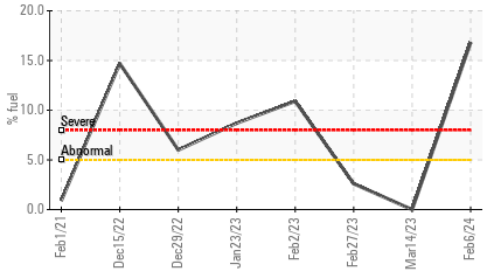
Fuel Dilution

There is a high amount of fuel present in the oil.

| Test | UOM | Method | Limit/Abn | Current | History1 | History2 |
|---|---|---|---|---|---|---|
| Fuel | % | ASTM D3524 | >5 | **16.8** | <1.0 | <1.0 |

We advise that you check the fuel injection system. Oil and filter change at the time of sampling has been noted. We recommend an early resample to monitor this condition.

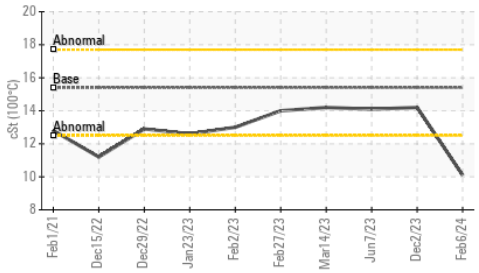
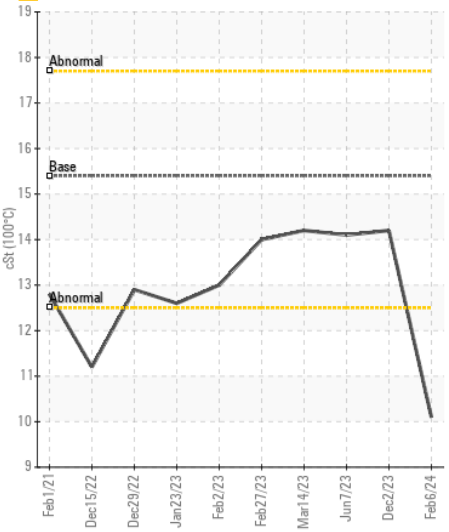
Viscosity @ 100°C

Fuel is present in the oil and is lowering the viscosity. The BN result indicates that there is suitable alkalinity remaining in the oil. The oil is no longer serviceable due to the presence of contaminants.

| Test | UOM | Method | Limit/Abn | Current | History1 | History2 |
|---|---|---|---|---|---|---|
| Visc @ 100°C | cSt | ASTM D445 | 15.4 | **10.1** | 14.2 | 14.1 |

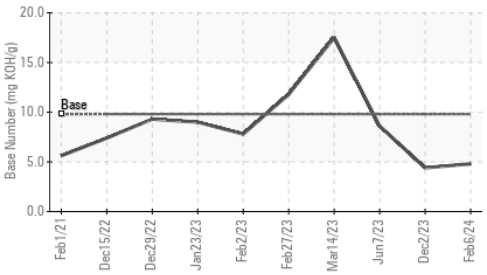
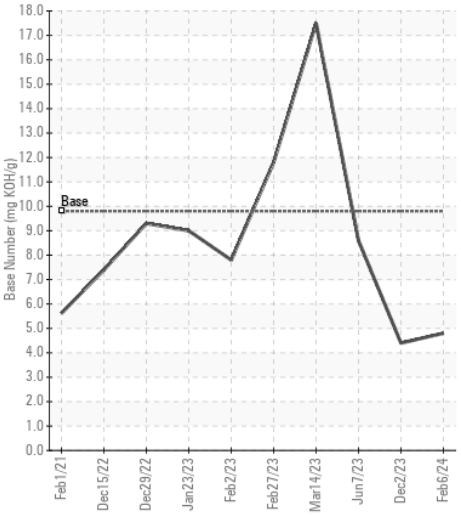
| Test | UOM | Method | Limit/Abn | Current | History1 | History2 |
|---|---|---|---|---|---|---|
| Base Number (BN) | mg KOH/g | ASTM D2896 | 9.8 | **4.8** | 4.4 | 8.6 |

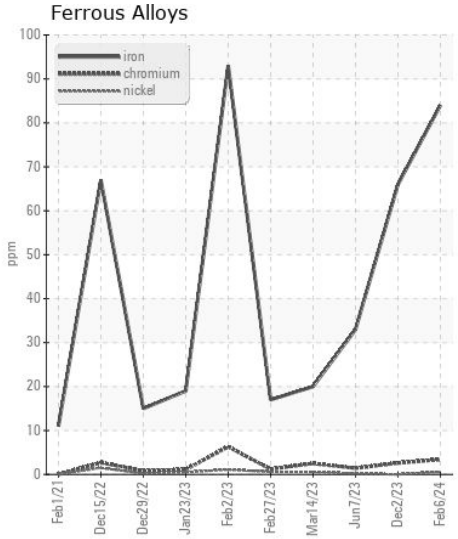
Ferrous Alloys

All component wear rates are normal.
