OIL ANALYSIS REPORT

Area
[12046]
Machine Id
VOLVO A35D 72314
Component
Diesel Engine
Fluid
MOBIL 15W40 (--- GAL)

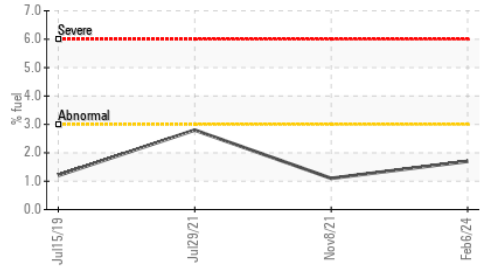
Fuel Dilution

Light fuel dilution occurring. No other contaminants were detected in the oil.

No corrective action is recommended at this time. Resample at the next service interval to monitor.

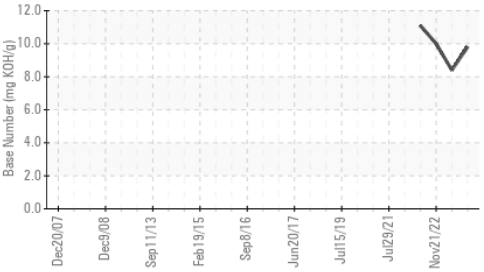
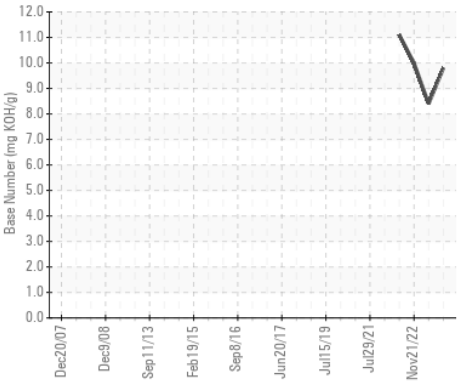
Base Number

The BN result indicates that there is suitable alkalinity remaining in the oil. The condition of the oil is suitable for further service.
