OIL ANALYSIS REPORT

Machine Id
PETERBILT 846-4309
Component
1 Diesel Engine
Fluid
{not provided} (--- GAL)

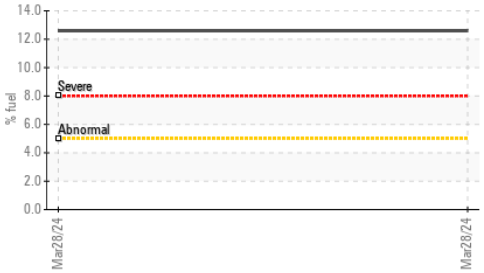
Fuel Dilution

There is a high amount of fuel present in the oil.

Fuel	%	ASTM D3524	>5	▲ 12.6	---	---
Water		WC Method	>0.2	NEG	---	---
Glycol		WC Method		NEG	---	---
Soot %	%	*ASTM D7844	>3	1	---	---
Nitration	Abs/cm	*ASTM D7624	>20	14.8	---	---
Sulfation	Abs/.1mm	*ASTM D7415	>30	27.8	---	---
Silt	scalar	*Visual	NONE	NONE	---	---
Debris	scalar	*Visual	NONE	NONE	---	---
Sand/Dirt	scalar	*Visual	NONE	NONE	---	---
Appearance	scalar	*Visual	NORML	NORML	---	---
Odor	scalar	*Visual	NORML	NORML	---	---
Emulsified Water	scalar	*Visual	>0.2	NEG	---	---
Sodium	ppm	ASTM D5185m		4	---	---
Boron	ppm	ASTM D5185m		22	---	---
Barium	ppm	ASTM D5185m		0	---	---
Molybdenum	ppm	ASTM D5185m		37	---	---
Manganese	ppm	ASTM D5185m		<1	---	---
Magnesium	ppm	ASTM D5185m		552	---	---
Calcium	ppm	ASTM D5185m		1724	---	---
Phosphorus	ppm	ASTM D5185m		768	---	---
Zinc	ppm	ASTM D5185m		901	---	---
Sulfur	ppm	ASTM D5185m		2446	---	---
Oxidation	Abs/.1mm	*ASTM D7414	>25	32.4	---	---
Base Number (BN)	mg KOH/g	ASTM D2896		5.2	---	---

We advise that you check the fuel injection system. Oil and filter change at the time of sampling has been noted. We recommend an early resample to monitor this condition.

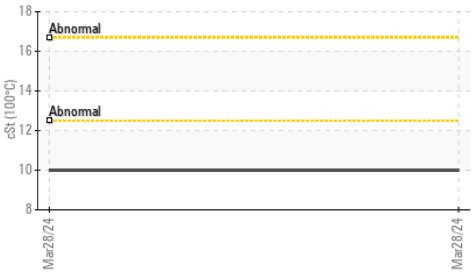
Viscosity @ 100°C

Fuel is present in the oil and is lowering the viscosity. The BN result indicates that there is suitable alkalinity remaining in the oil. The oil is no longer serviceable due to the presence of contaminants.

Visc @ 100°C	cSt	ASTM D445		▲ 10.0	---	---

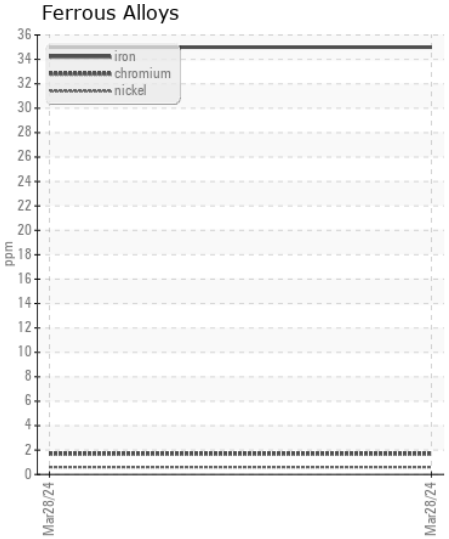
Ferrous Alloys

All component wear rates are normal.
