MOBIL VOLVO

OIL ANALYSIS REPORT

Area
## [SWA540568 MULCH CTR]
Machine Id
## VOLVO L90D 64482

Component
## Diesel Engine
Fluid
## MOBIL DELVAC 1300 SUPER15W40 (--- GAL)

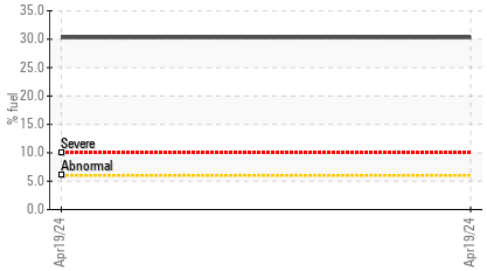
Fuel Dilution

There is a high amount of fuel present in the oil.

| Test | UOM | Method | Limit/Abn | Current | History1 | History2 |
|---|---|---|---|---|---|---|
| Fuel | % | ASTM D3524 | >6.0 | ▲ 30.3 | <1.0 | --- |

We advise that you check the fuel injection system. We recommend that you drain the oil and perform a filter service on this component if not already done. We recommend an early resample to monitor this condition.

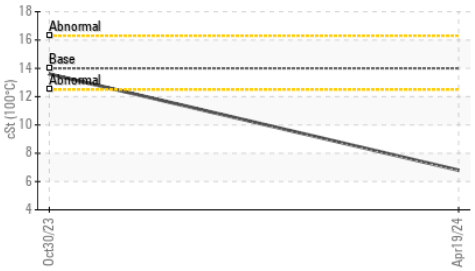
Viscosity @ 100°C

Fuel is present in the oil and is lowering the viscosity. The BN result indicates that there is suitable alkalinity remaining in the oil. The oil is no longer serviceable due to the presence of contaminants.

| Test | UOM | Method | Limit/Abn | Current | History1 | History2 |
|---|---|---|---|---|---|---|
| Visc @ 100°C | cSt | ASTM D445 | 14 | ▲ 6.8 | 13.6 | --- |

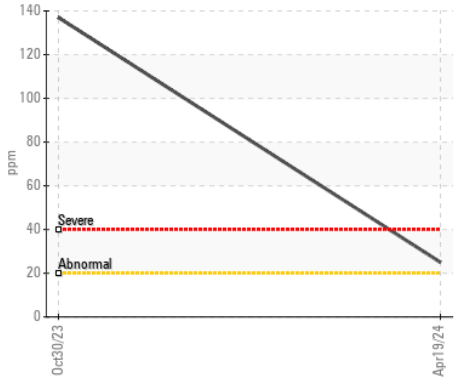
Silicon (ppm)

| Test | UOM | Method | Limit/Abn | Current | History1 | History2 |
|---|---|---|---|---|---|---|
| Silicon | ppm | ASTM D5185m | >20 | 25 | ▲ 137 | --- |
