IDEALEASE FLEET

OIL ANALYSIS REPORT

Machine Id
441407
Component
Diesel Engine
Fluid
VALVOLINE 15W40 (--- GAL)

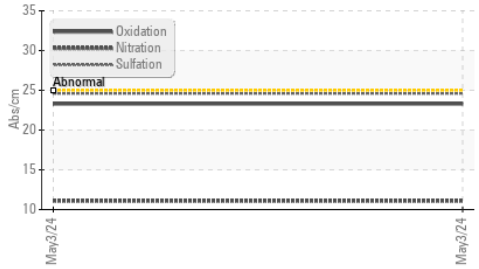
FT-IR (Direct Trend)

Elevated aluminum (Al) and/or lead (Pb) and potassium (K) levels in your metals analysis are likely a result of solder flux release into the lubricant and is common on new equipment/components. There is no indication of any contamination in the oil.

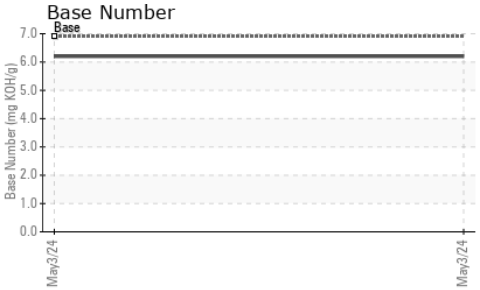
Base Number

The BN result indicates that there is suitable alkalinity remaining in the oil. The condition of the oil is suitable for further service.

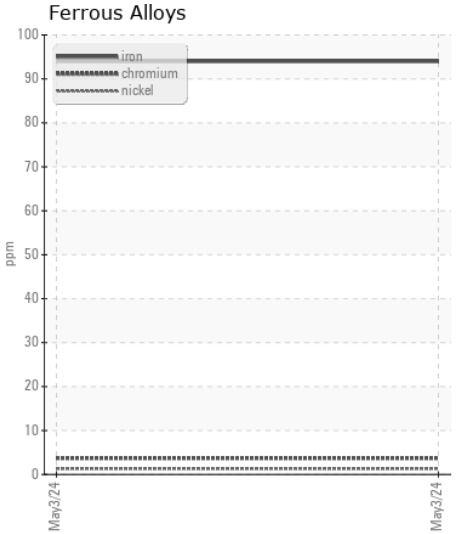
Ferrous Alloys

Metal levels are typical for a new component breaking in.
