James River Equipment

OIL ANALYSIS REPORT

Machine Id
JOHN DEERE 624 P 1DW624PACRLX21662
Component
Diesel Engine
Fluid
{not provided} (--- GAL)

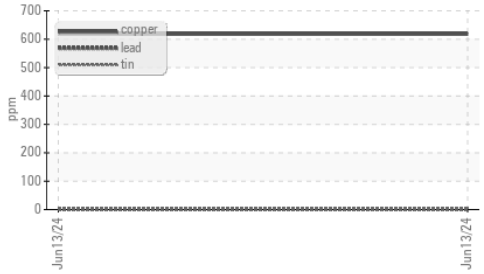
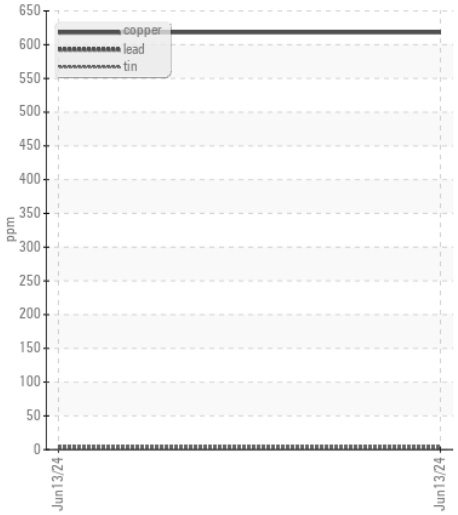
Non-ferrous Metals

The copper level is abnormal. In the absence of other significant wear metals, suspect copper due to sources other than wear (i.e. cooling core). All other metal levels are typical for a new component breaking in.

No corrective action is recommended at this time. Resample at the next service interval to monitor. Please specify the brand, type, and viscosity of the oil on your next sample.
