IDEALEASE FLEET

OIL ANALYSIS REPORT

Machine Id
6211691
Component
Diesel Engine
Fluid
{not provided} (--- GAL)

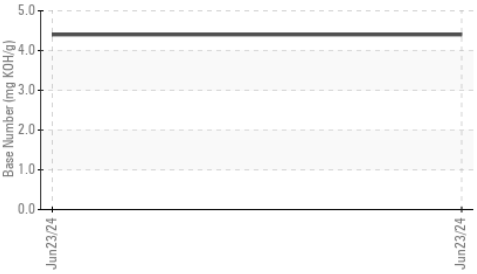
Base Number

The BN result indicates that there is suitable alkalinity remaining in the oil. The condition of the oil is acceptable for the time in service.

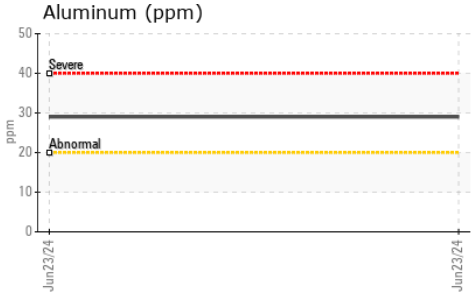
Aluminum (ppm)

Elevated aluminum (Al) and/or lead (Pb) and potassium (K) levels in your metals analysis are likely a result of solder flux release into the lubricant and is common on new equipment/components. No other contaminants were detected in the oil.
