OIL ANALYSIS REPORT

Area
[HERC RENTAL]
Machine Id
VOLVO A30G 753485
Component
Bogie/Center Axle
Fluid
VOLVO PREMIUM GEAR OIL 85W-140 GL-5 (--- GAL)

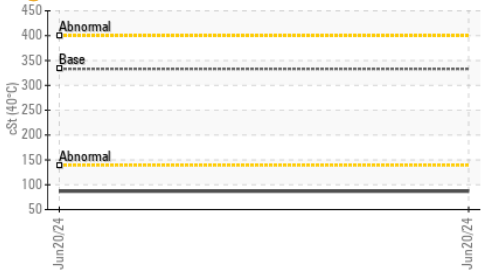
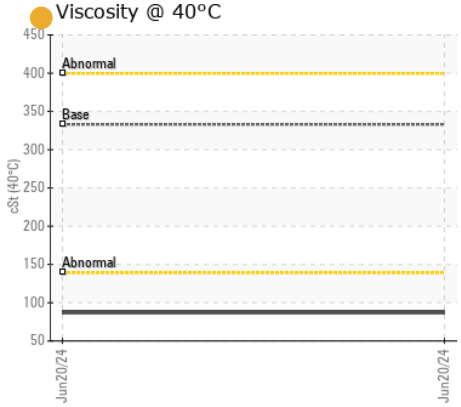
Viscosity @ 40°C

The oil viscosity is lower than normal. This plus the additive levels indicates the addition of a different brand, or type of oil. Confirm oil type.

Resample at the next service interval to monitor.

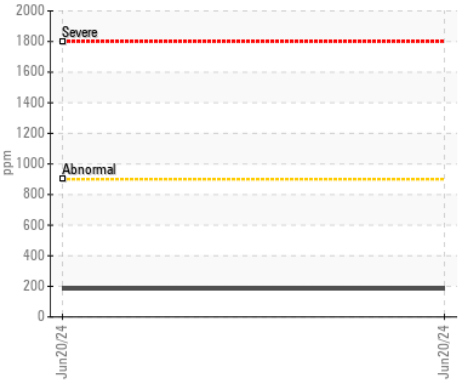
Iron (ppm)

All component wear rates are normal.

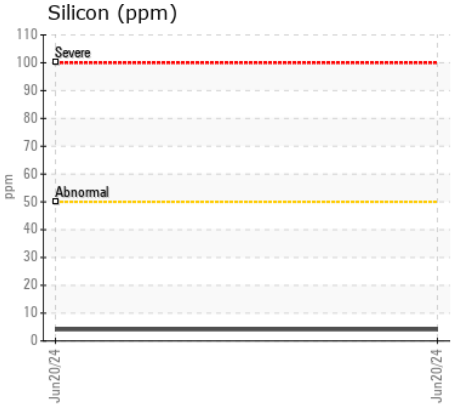
Silicon (ppm)

There is no indication of any contamination in the oil.
