OIL ANALYSIS REPORT

Area
BRUCE A/1/33120
Machine Id
1-33120-P3-PM Lower Brg
Component
Lower Guide Bearing
Fluid
MOBIL DTE 746 (21 GAL)

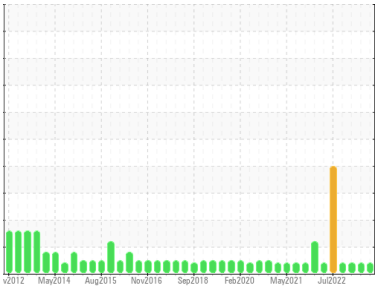
Sample Rating Trend

VISCOSITY

Sample Status				**ABNORMAL**	ABNORMAL	ABNORMAL
Visc @ 40°C	cSt	ASTM D7279(m)	44.0	▲ **31.1**	▲ 31.1	▲ 31.0

Resample at the next service interval to monitor.

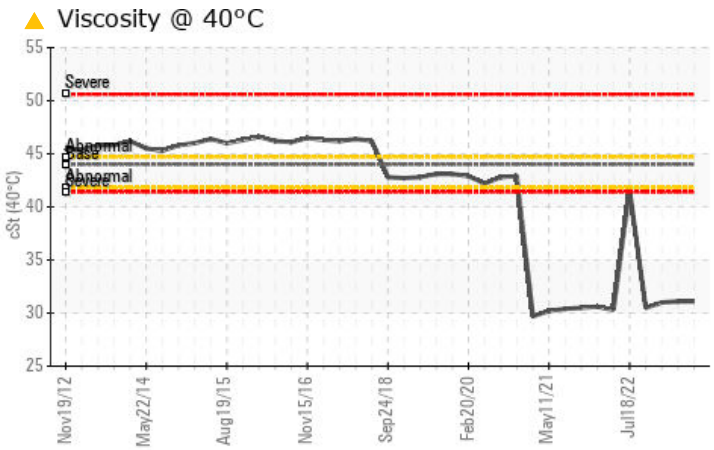
COMPONENT CONDITION SUMMARY

Fluid Condition
Viscosity of sample indicates oil is within ISO 32 range, advise investigate. The AN level is acceptable for this fluid. The condition of the oil is suitable for further service.

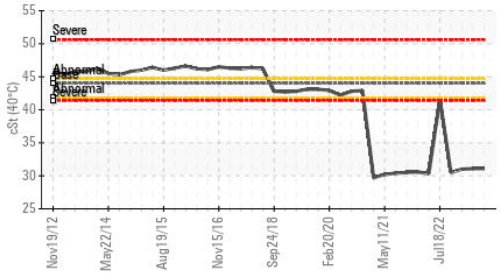
Viscosity @ 40°C

FLUID PROPERTIES		method	limit/base	current	history1	history2
Visc @ 40°C	cSt	ASTM D7279(m)	44.0	▲ **31.1**	▲ 31.1	▲ 31.0

Recommendation
Resample at the next service interval to monitor.

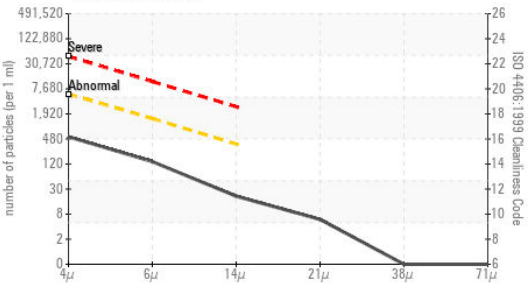
Particle Count

Contamination
The system cleanliness is acceptable for your target ISO 4406 cleanliness code. The water content is negligible. The system and fluid cleanliness is acceptable.

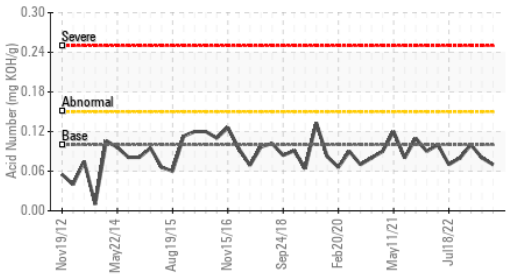
FLUID DEGRADATION		method	limit/base	current	history1	history2
Acid Number (AN)	mg KOH/g	ASTM D974*	0.10	**0.07**	0.08	0.10

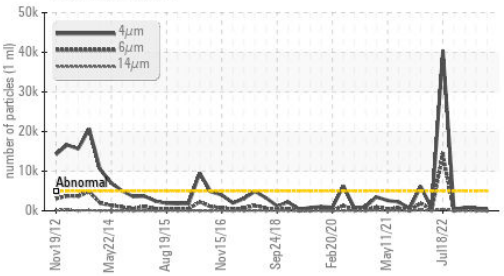
Particle Trend

FLUID CLEANLINESS	method	limit/base	current	history1	history2
Particles >4µm	ASTM D7647	>5000	**478**	638	864
Particles >6µm	ASTM D7647	>1300	**121**	258	288
Particles >14µm	ASTM D7647	>320	**18**	35	36
Particles >21µm	ASTM D7647	>80	**5**	10	10
Particles >38µm	ASTM D7647	>20	**0**	0	0
Particles >71µm	ASTM D7647	>4	**0**	0	0
Oil Cleanliness	ISO 4406 (c)	>19/17/15	**16/14/11**	16/15/12	17/15/12
