WANSON 5000 BH

Customer: PTRHTF40051	System Information	Sample Information
Onion Specialties International B.V... Nisseweg 8 Kruiningen, 4416PK Netherlands Attn: WILBERT SNIJERS Tel: E-Mail: w.snijers@klt.nl	System Volume: 7000 ltr Bulk Operating Temp: 290F / 143C Heating Source: Blanket: Fluid: PETRO CANADA PETRO-THERM Make: WANSON	Lab No: 02399433 Analyst: Matthias Voss Sample Date: 01/15/21 Received Date: 01/22/21 Completed: 01/27/21 Matthias Voss Matthias.Voss@petrocanadalsp.com

PETRO-CANADA LUBRICANTS

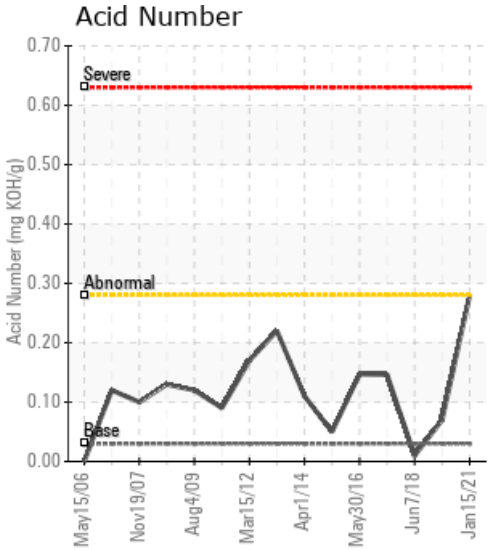
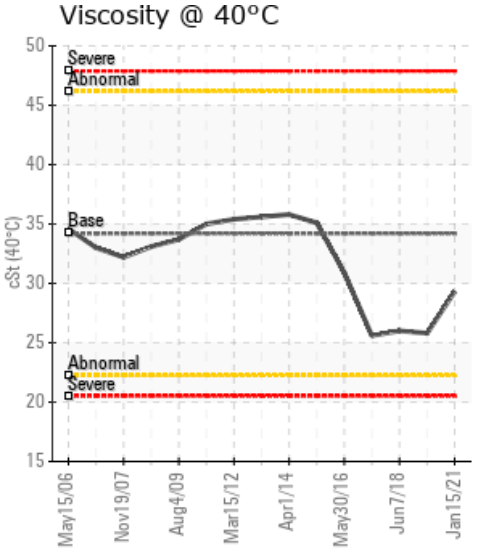
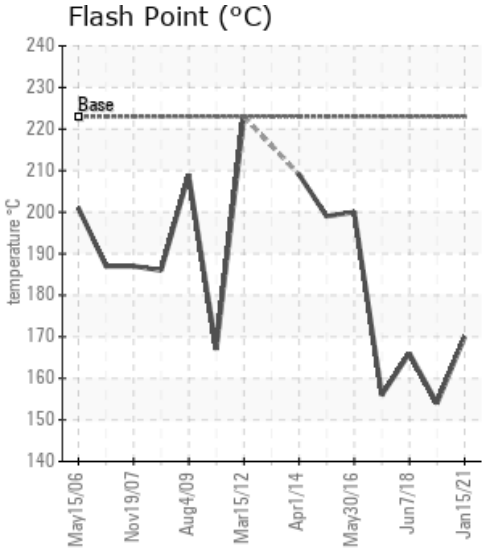
Comments: COC Flash Point is abnormally low.

Sample Date	Received Date	Fluid Age	Sample Location	Flash Point (COC)	Water (KF)	Viscosity (40°C)	Acid Number	Solids	GCD 10%	GCD 50%	GCD 90%	GCD % < 335°C
	mm/dd/yy			°F/°C	ppm	cSt	mg/KOH/g	%wt	°F/°C	°F/°C	°F/°C	%
01/15/21	01/22/21	7y		338 / 170	26.9	29.3	0.28	0.127	678 / 359	800 / 426	913 / 490	6.28
04/16/19	04/24/19	0y		309 / 154	24.3	25.8	0.07	0.108	684 / 362	796 / 425	907 / 486	4.87
06/07/18	06/11/18	4y		331 / 166	26.2	26.0	0.01	0.209	679 / 359	801 / 427	914 / 490	5.92
06/16/17	06/26/17	3y		313 / 156	26.2	25.6	0.146	0.075	667 / 353	793 / 423	931 / 499	6.79
05/30/16	06/03/16	2y	PTRHTF40051	392 / 200	24.0	30.9	0.147	0.098	701 / 372	802 / 428	916 / 491	1.44
Baseline Data				433 / 223		34.2	0.03		720 / 382	817 / 436	900 / 482	1.00

Recommendation: Fluid fit for further use. Please send in next sample at next service interval.
