PROBLEM SUMMARY

Area
1460
Machine Id
1460-5666-4001 - HG Ni THICKENER MECH HPU
Component
Hydraulic System
Fluid
PETRO CANADA HYDREX MV 36 (100 LTR)

OIL ANALYSIS REPORT

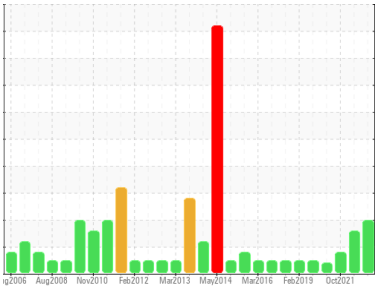
Sample Rating Trend

Sample Status				ABNORMAL	ABNORMAL	ABNORMAL
Particles >4µm		ASTM D7647	>5000	▲ **14261**	▲ 25768	▲ 35120
Particles >6µm		ASTM D7647	>1300	▲ **3761**	▲ 6713	▲ 4933
Particles >14µm		ASTM D7647	>160	▲ **423**	▲ 422	71
Particles >21µm		ASTM D7647	>40	▲ **139**	▲ 79	17
Oil Cleanliness		ISO 4406 (c)	>19/17/14	▲ **21/19/16**	▲ 22/20/16	▲ 22/19/13

We advise that you perform a filter service, and use off-line filtration to improve the cleanliness of the system fluid. We recommend an early resample to monitor this condition.

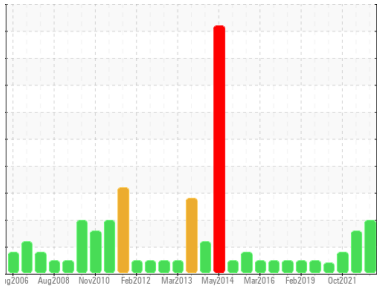
Sample Rating Trend

There is a moderate amount of particulates (2 to 100 microns in size) present in the oil.

The AN level is acceptable for this fluid. The oil is still serviceable provided that the contaminant(s) can be reduced to acceptable levels.

We advise that you perform a filter service, and use off-line filtration to improve the cleanliness of the system fluid. We recommend an early resample to monitor this condition.

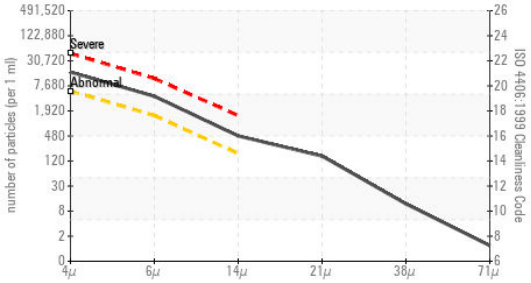
Particle Count

FLUID CLEANLINESS		method	limit/base	current	history 1	history 2
Particles >4µm		ASTM D7647	>5000	▲ **14261**	▲ 25768	▲ 35120
Particles >6µm		ASTM D7647	>1300	▲ **3761**	▲ 6713	▲ 4933
Particles >14µm		ASTM D7647	>160	▲ **423**	▲ 422	71
Particles >21µm		ASTM D7647	>40	▲ **139**	▲ 79	17
Particles >38µm		ASTM D7647	>10	**10**	7	2
Particles >71µm		ASTM D7647	>3	**1**	0	0
Oil Cleanliness		ISO 4406 (c)	>19/17/14	▲ **21/19/16**	▲ 22/20/16	▲ 22/19/13

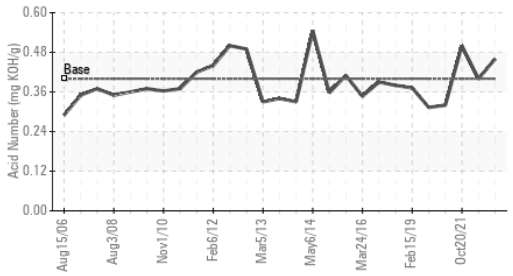
FLUID DEGRADATION		method	limit/base	current	history 1	history 2
Acid Number (AN)	mg KOH/g	ASTM D974*	0.40	**0.46**	0.40	0.50
