PROBLEM SUMMARY

Area
1460
Machine Id
1460-5652-4014 - HGNi CONCENTRATE TANK 1 AGITATOR
Component
Gearbox
Fluid
PETRO CANADA ENDURATEX SYNTHETIC EP 220 (100 LTR)

OIL ANALYSIS REPORT

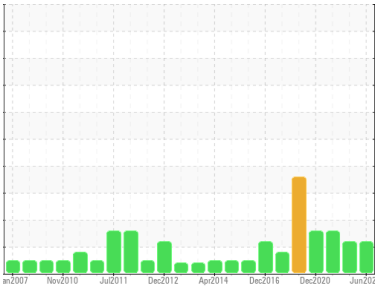
Sample Rating Trend

Sample Status				ATTENTION	ABNORMAL	ABNORMAL
Particles >4µm		ASTM D7647	>20000	▲ **30977**	▲ 114322	▲ 103193
Particles >6µm		ASTM D7647	>5000	▲ **7545**	▲ 30946	▲ 28029
Oil Cleanliness		ISO 4406 (c)	>21/19/16	▲ **22/20/15**	▲ 24/22/17	▲ 24/22/18

We recommend you service the filters on this component. Resample at the next service interval to monitor.

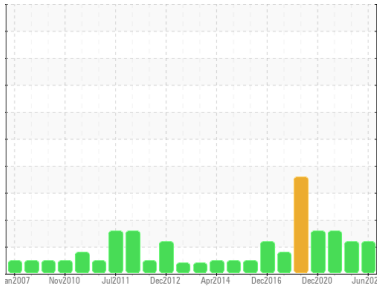
Sample Rating Trend

Wear
All component wear rates are normal.

Contamination
There is a light amount of silt (particulates < 14 microns in size) present in the oil.

Fluid Condition
The AN level is acceptable for this fluid. The condition of the oil is suitable for further service.

Recommendation
We recommend you service the filters on this component. Resample at the next service interval to monitor.

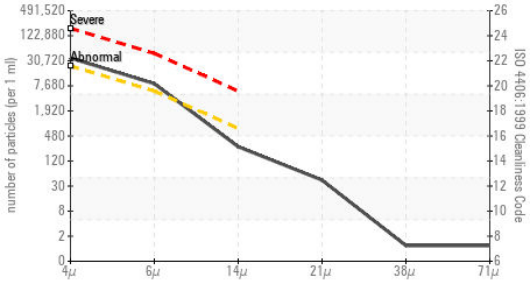
Particle Count

FLUID CLEANLINESS		method	limit/base	current	history 1	history 2
Particles >4µm		ASTM D7647	>20000	▲ **30977**	▲ 114322	▲ 103193
Particles >6µm		ASTM D7647	>5000	▲ **7545**	▲ 30946	▲ 28029
Particles >14µm		ASTM D7647	>640	**233**	▲ 839	▲ 1580
Particles >21µm		ASTM D7647	>160	**37**	133	▲ 289
Particles >38µm		ASTM D7647	>40	**1**	0	3
Particles >71µm		ASTM D7647	>10	**1**	0	0
Oil Cleanliness		ISO 4406 (c)	>21/19/16	▲ **22/20/15**	▲ 24/22/17	▲ 24/22/18

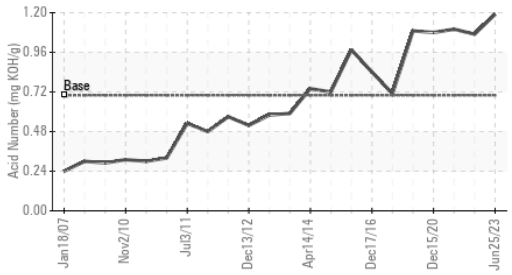
FLUID DEGRADATION		method	limit/base	current	history 1	history 2
Acid Number (AN)	mg KOH/g	ASTM D974*	0.7	**1.19**	1.07	1.10
